2015 FACILITY CONDITION SURVEY

Seattle Central Community
College

SURVEY CONDUCTED BY:
Steve Lewandowski
State Board for Community
and Technical Colleges

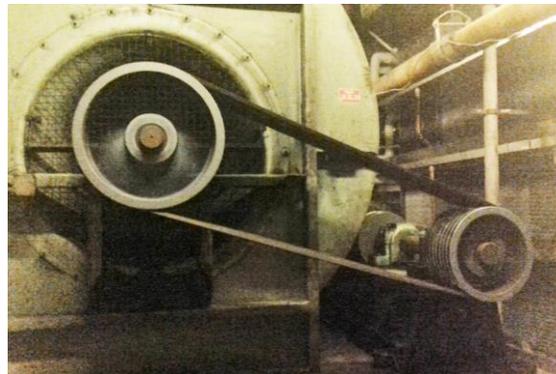
The SF-1 motor that drives the HVAC supply air fan is over 40 years old. The motor's reliability is questionable and shows signs of deterioration. The motor should be replaced. The drive shaft assembly is also the same age and shows signs of deterioration. The shaft and bearings should be replaced.

Recommended funding schedule : Immediate
Estimated remaining life (years) : 3
Estimated average life expectancy (years) : 25
Scoring priority category 1 : High Repair/Repl. Cost
Category 1 percentage : 60 %
Scoring priority category 2 : System Use
Category 2 percentage : 40 %
Project construction estimate (MACC): \$601,000
Total repair estimate (including soft costs): \$855,000
Deficiency score : 53

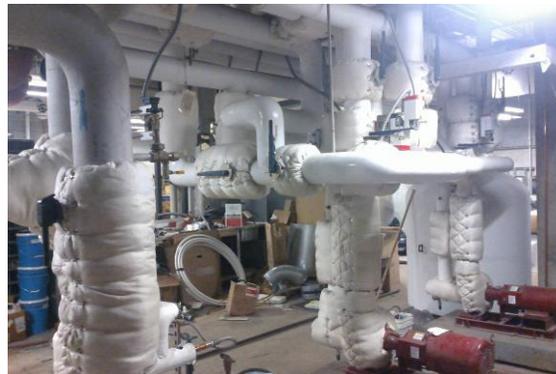
Deficiency F02

The heating loop piping may be nearing the end of its useful life. Leaks have been developing and the pipe should be formally evaluated to determine the cause and extent of the problem so a repair can be recommended.

Estimated average life expectancy (years) : 25
Scoring priority category 1 : High Repair/Repl. Cost
Category 1 percentage : 50 %
Scoring priority category 2 : System Use
Category 2 percentage : 50 %
Project construction estimate (MACC): No Data
Total repair estimate (including soft costs): No Data
Deficiency score : Needs study

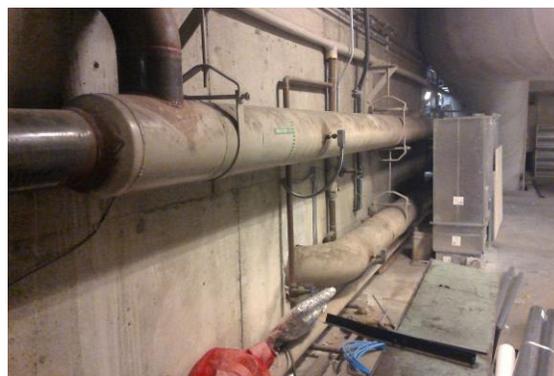
Deficiency F03

The cooling tower condensing water lines have begun flaking the interior surface of the pipe. The lines still function as designed. This deterioration will lead to thinning pipe walls and eventually leaks. The pipes should be formally evaluated to determine the extent of the problem and root cause. Then a repair can be recommended.

Recommended funding schedule : Deferred Backlog
Estimated remaining life (years) : 7
Estimated average life expectancy (years) : 40
Scoring priority category 1 : High Operating Cost
Category 1 percentage : 50 %
Scoring priority category 2 : High Repair/Repl. Cost
Category 2 percentage : 50 %
Project construction estimate (MACC): No Data
Total repair estimate (including soft costs): No Data
Deficiency score : Needs study

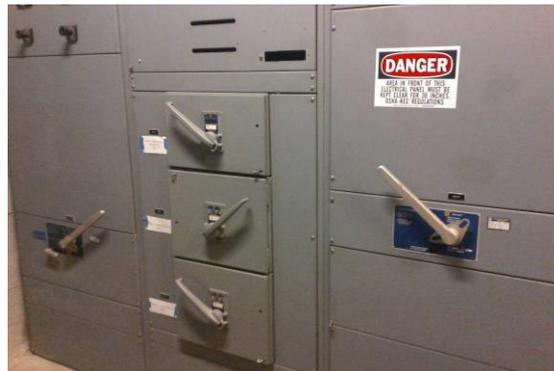
Deficiency F04

The main switch gear has deteriorated and in some cases failed when switching off and on. The facility staff indicated that one of the contactors had disintegrated when the switch was recently engaged. Repairs were made to extend the life of the switch. At the time of the survey, the extent of the deterioration was not clear other than the one recently failed switch. This type of gear typically lasts more than 50 years. The equipment should continue to be monitored and further evaluated to be considered for replacement in the future.

Recommended funding schedule : Fund in Next Biennium
Estimated remaining life (years) : 5
Estimated average life expectancy (years) : 50
Scoring priority category 1 : System Use
Category 1 percentage : 80 %
Scoring priority category 2 : Facility Use
Category 2 percentage : 20 %
Project construction estimate (MACC): \$1,170,000
Total repair estimate (including soft costs): \$1,665,000
Deficiency score : 40

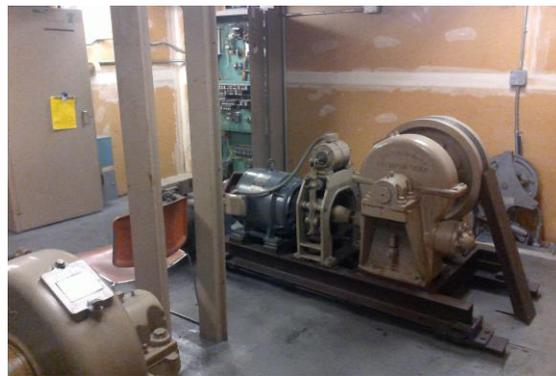
Deficiency F05

Elevators 1 and 2 have experienced heavy use, but still function. Maintenance provided by the Elevator service contractor is increasing in frequency and cost. The elevator vendor has recommended rebuilding the equipment. Rebuilding the elevator machine room equipment and controls requires that new cooling be provided. These elevators should continue to be monitored and be considered for repairs next biennium.

Estimated remaining life (years) : 5
Estimated average life expectancy (years) : 40
Scoring priority category 1 : System Use
Category 1 percentage : 80 %
Scoring priority category 2 : Facility Use
Category 2 percentage : 20 %
Project construction estimate (MACC): \$498,000
Total repair estimate (including soft costs): \$708,000
Deficiency score : 40

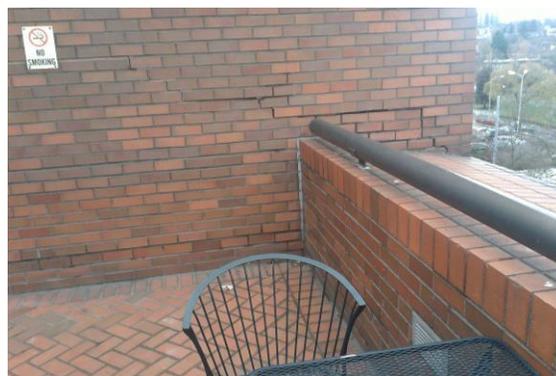
Deficiency F06

The various rooftop patios leak and allow water to penetrate the building envelope. One patio has been funded for repair in the current biennium. There are three more patios of the same type that also leak. The leaks are penetrating the surface and adjacent masonry surfaces and exiting through the soffits below. The water is damaging the soffits. The remaining three patios and associated damage should be repaired.

Recommended funding schedule : Immediate
Estimated remaining life (years) : 3
Estimated average life expectancy (years) : 30
Scoring priority category 1 : High Repair/Repl. Cost
Category 1 percentage : 60 %
Scoring priority category 2 : System Use
Category 2 percentage : 40 %
Project construction estimate (MACC): \$350,000
Total repair estimate (including soft costs): \$498,000
Deficiency score : 53

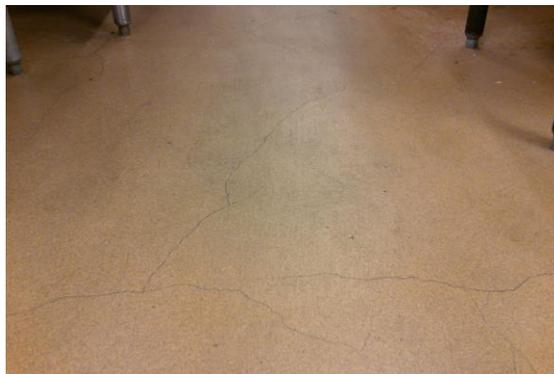
Deficiency F07

The kitchen floor is a hardened surface installed over the concrete slab. The epoxy surface exhibits some fine cracking and should be replaced when the cracks become more severe.

Scoring priority category 1 : High Repair/Repl. Cost
Category 1 percentage : 70 %
Scoring priority category 2 : Quality of Use
Category 2 percentage : 30 %
Project construction estimate (MACC): \$186,000
Total repair estimate (including soft costs): \$264,000
Deficiency score : 10

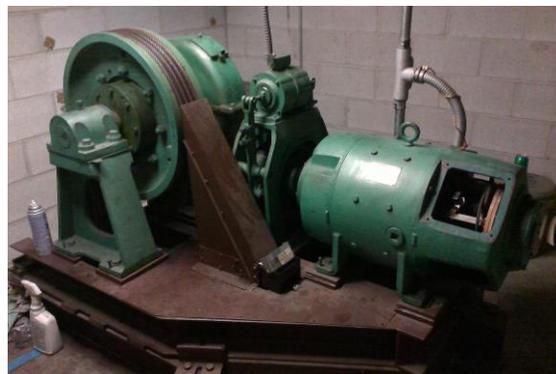
Deficiency F08

Estimated remaining life (years) : 5
Estimated average life expectancy (years) : 40
Scoring priority category 1 : System Use
Category 1 percentage : 90 %
Scoring priority category 2 : Facility Use
Category 2 percentage : 10 %
Project construction estimate (MACC): \$258,000
Total repair estimate (including soft costs): \$367,000
Deficiency score : 39

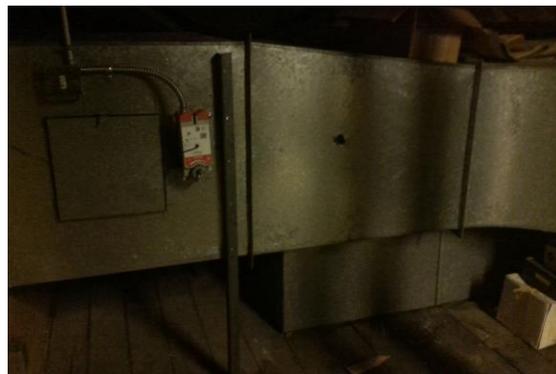
Deficiency F09

The air handler units (1, 2, 3 and multi-unit) are 35 years old and show signs of deterioration. Some components have been replaced. Since components have recently been replaced and the units are still functioning, it is recommended that the units be monitored and maintained to further extend their useful life. If future repair costs exceed 50% of the value of the unit, then a replacement will be warranted.

Recommended funding schedule : Fund in Next Biennium
Estimated remaining life (years) : 5
Estimated average life expectancy (years) : 25
Scoring priority category 1 : High Repair/Repl. Cost
Category 1 percentage : 90 %
Scoring priority category 2 : System Use
Category 2 percentage : 10 %
Project construction estimate (MACC): \$140,000
Total repair estimate (including soft costs): \$199,000
Deficiency score : 31

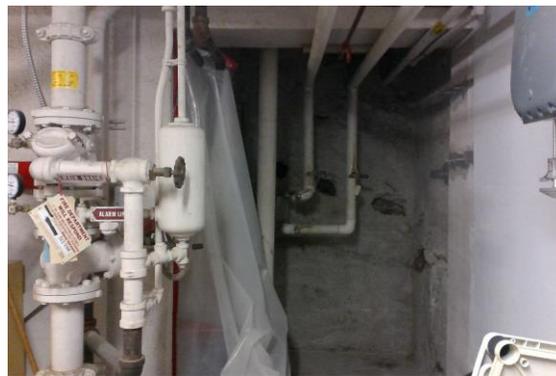
Deficiency F10

The college indicated that the main water line has rusted and corroded. Much of the line is insulated and could not be observed. The line still functions as designed. It is recommended that the facility monitor and formally assess the condition of the pipe (internal condition and remaining life) to justify replacement. This request for information was also made last biennium.

Recommended funding schedule : Fund in Next Biennium
Estimated remaining life (years) : 5
Estimated average life expectancy (years) : 50
Scoring priority category 1 : System Use
Category 1 percentage : 70 %
Scoring priority category 2 : Facility Use
Category 2 percentage : 30 %
Project construction estimate (MACC): No Data
Total repair estimate (including soft costs): No Data
Deficiency score : Needs study

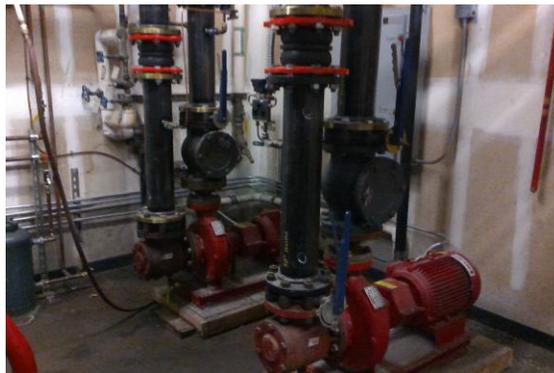
Deficiency F11

The facility staff has concerns that the PVC portions of the heat pump loop will become brittle and leak. The college was not able to provide evidence of PVC leaks during the survey (located in hard to reach locations in the ceiling). Part of the loop has been replaced with copper or galvanized steel to address leaks, but much of the loop within the building is still PVC. The PVC should be monitored and formally investigated (condition and remaining life) to justify replacement.

Recommended funding schedule : Fund in Next Biennium
Estimated remaining life (years) : 5
Estimated average life expectancy (years) : 30
Scoring priority category 1 : High Repair/Repl. Cost
Category 1 percentage : 90 %
Scoring priority category 2 : System Use
Category 2 percentage : 10 %
Project construction estimate (MACC): No Data
Total repair estimate (including soft costs): No Data
Deficiency score : Needs study

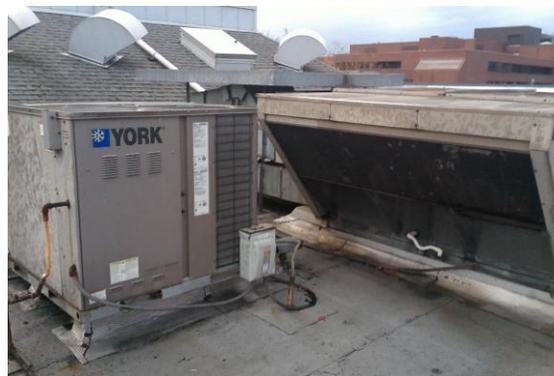
Deficiency F12

The three rooftop HVAC units serving the building (one serving each floor). The college is concerned about the age of the units. The units still function and should continue to be monitored for future replacement.

Scoring priority category 1 : High Repair/Repl. Cost
Category 1 percentage : 60 %
Scoring priority category 2 : System Use
Category 2 percentage : 40 %
Project construction estimate (MACC): \$135,000
Total repair estimate (including soft costs): \$192,000
Deficiency score : 33

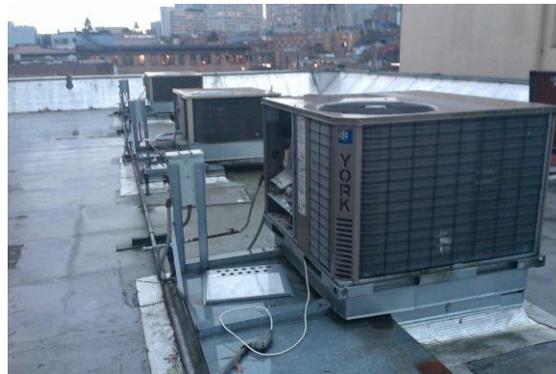
Deficiency F13

The facility staff have concerns that the three HVAC rooftop units are nearing the end of their useful life. The units no longer function and should be replaced.

Category 1 percentage : 70 %
Scoring priority category 2 : System Use
Category 2 percentage : 30 %
Project construction estimate (MACC): \$99,000
Total repair estimate (including soft costs): \$140,000
Deficiency score : 32

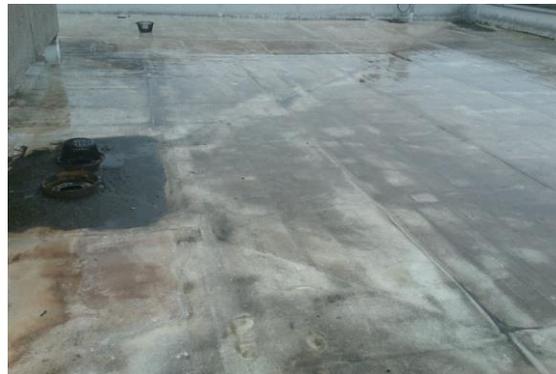
Deficiency F14

Estimated remaining life (years) : 5
Estimated average life expectancy (years) : 25
Scoring priority category 1 : System Use
Category 1 percentage : 80 %
Scoring priority category 2 : Facility Use
Category 2 percentage : 20 %
Project construction estimate (MACC): \$110,000
Total repair estimate (including soft costs): \$156,000
Deficiency score : 40

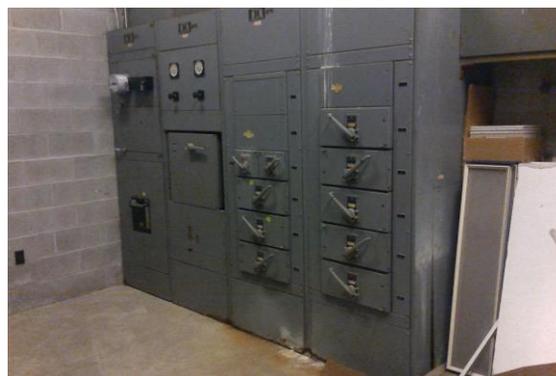
Deficiency F15

Recommended funding schedule : Deferred Backlog
Estimated remaining life (years) : 7
Estimated average life expectancy (years) : 50
Scoring priority category 1 : Facility Use
Category 1 percentage : 80 %
Scoring priority category 2 : Facility Use
Category 2 percentage : 20 %
Project construction estimate (MACC): \$470,000
Total repair estimate (including soft costs): \$669,000
Deficiency score : 20

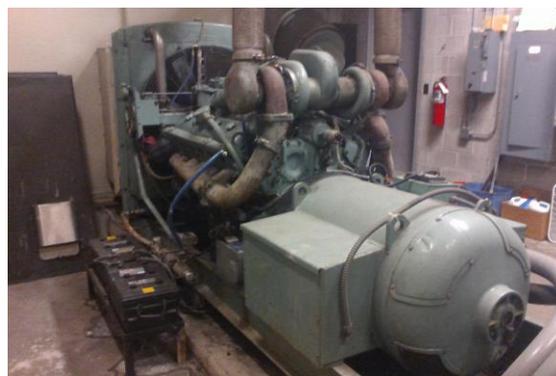
Deficiency F16

Recommended funding schedule : Immediate
Estimated remaining life (years) : 3
Estimated average life expectancy (years) : 30
Scoring priority category 1 : System Use
Category 1 percentage : 80 %
Scoring priority category 2 : Health/Safety
Category 2 percentage : 20 %
Project construction estimate (MACC): \$1,028,000
Total repair estimate (including soft costs): \$1,463,000
Deficiency score : 68

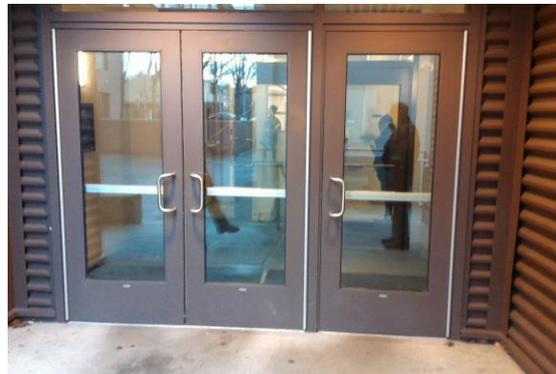
Deficiency F17

Estimated remaining life (years) : 5
Estimated average life expectancy (years) : 25
Scoring priority category 1 : High Repair/Repl. Cost
Category 1 percentage : 100 %
Scoring priority category 2 : None
Category 2 percentage : 0 %
Project construction estimate (MACC): \$409,000
Total repair estimate (including soft costs): \$582,000
Deficiency score : 30

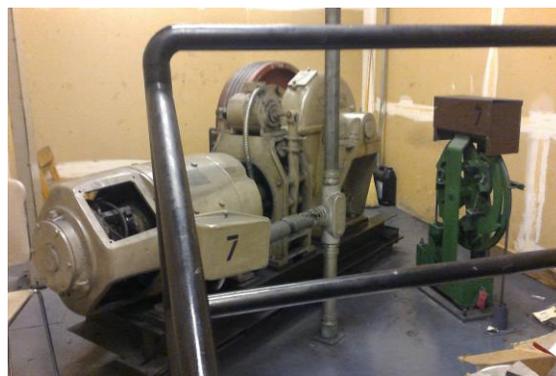
Deficiency F18

Recommended funding schedule : Fund in Next Biennium
Estimated remaining life (years) : 5
Estimated average life expectancy (years) : 40
Scoring priority category 1 : System Use
Category 1 percentage : 80 %
Scoring priority category 2 : Facility Use
Category 2 percentage : 20 %
Project construction estimate (MACC): \$258,000
Total repair estimate (including soft costs): \$367,000
Deficiency score : 40

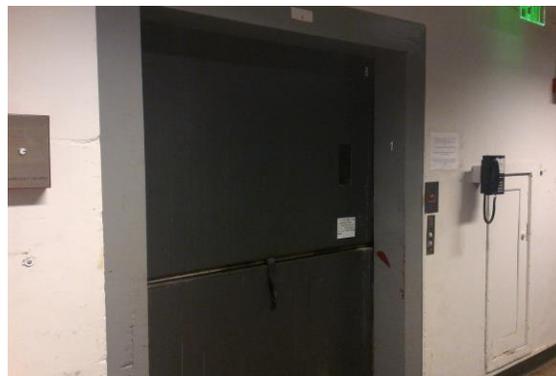
Deficiency F19

Estimated remaining life (years) : 3
Estimated average life expectancy (years) : 40
Scoring priority category 1 : High Repair/Repl. Cost
Category 1 percentage : 80 %
Scoring priority category 2 : Facility Use
Category 2 percentage : 20 %
Project construction estimate (MACC): \$258,000
Total repair estimate (including soft costs): \$367,000
Deficiency score : 54

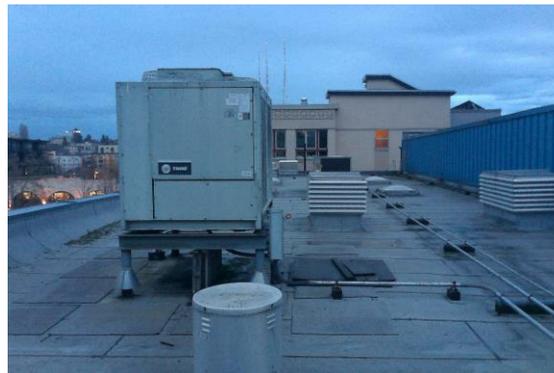
Deficiency F20

Recommended funding schedule : Fund in Next Biennium
Estimated remaining life (years) : 5
Estimated average life expectancy (years) : 30
Scoring priority category 1 : High Repair/Repl. Cost
Category 1 percentage : 60 %
Scoring priority category 2 : System Use
Category 2 percentage : 40 %
Project construction estimate (MACC): \$166,000
Total repair estimate (including soft costs): \$236,000
Deficiency score : 33

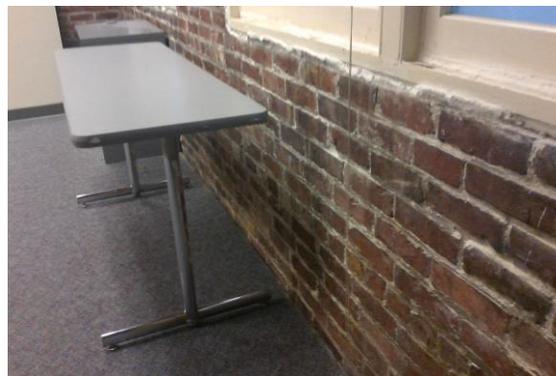
Deficiency F21

Estimated remaining life (years) : 3
Estimated average life expectancy (years) : 40
Scoring priority category 1 : High Repair/Repl. Cost
Category 1 percentage : 80 %
Scoring priority category 2 : Facility Use
Category 2 percentage : 20 %
Project construction estimate (MACC): \$222,000
Total repair estimate (including soft costs): \$316,000
Deficiency score : 54

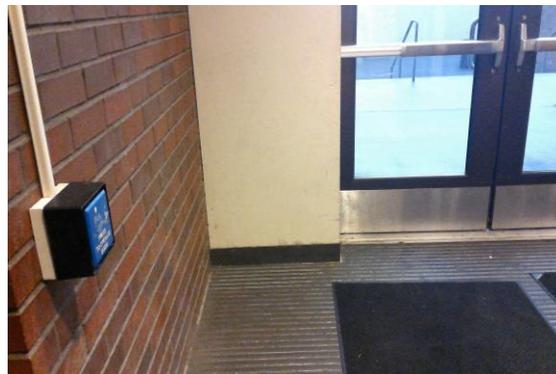
Deficiency F22

Category 1 percentage : 60 %
Scoring priority category 2 : System Use
Category 2 percentage : 40 %
Project construction estimate (MACC): \$80,000
Total repair estimate (including soft costs): \$113,000
Deficiency score : 53

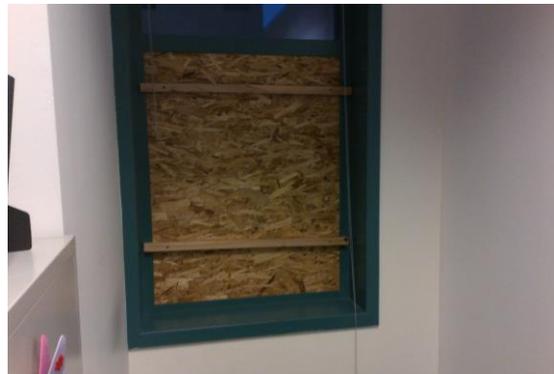
Deficiency F23

Estimated average life expectancy (years) : 40
Scoring priority category 1 : High Repair/Repl. Cost
Category 1 percentage : 60 %
Scoring priority category 2 : System Use
Category 2 percentage : 40 %
Project construction estimate (MACC): \$650,000
Total repair estimate (including soft costs): \$925,000
Deficiency score : 53

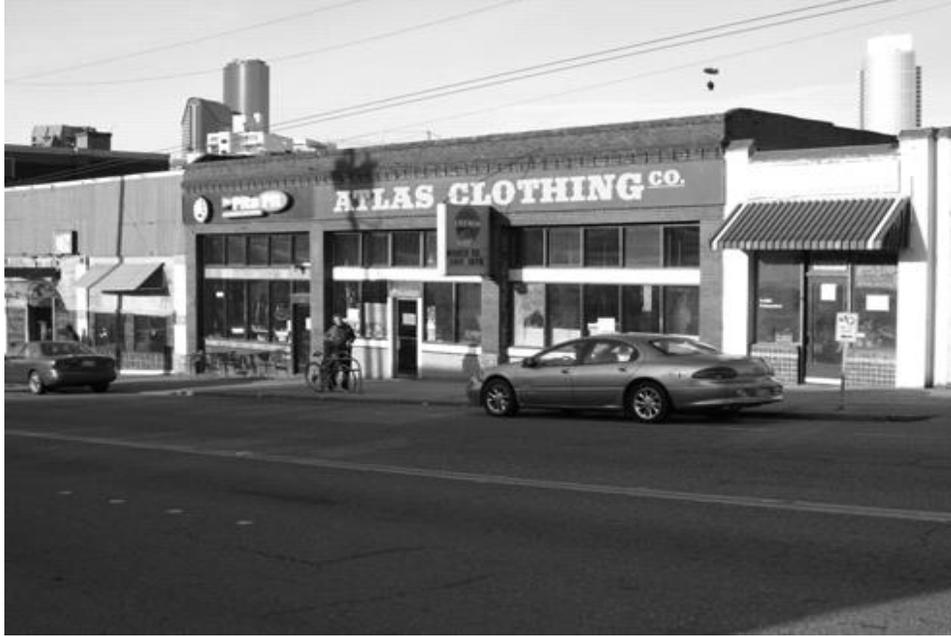
Atlas Building (062-AB) STATE UFI: A05163 Main Campus (062A)
 AREA: 7,200 SF BUILT: No data REMODELED: No PREDOMINANT USE: Storage
 CONSTRUCTION TYPE: Medium CRV/SF: \$290 REPLACEMENT VALUE: \$2,088,000

Primary Systems	
COMPONENT: Structure	RATING: 5 x WEIGHT: 8.3 = SCORE: 41.7
Visible settlement and potential structural failure; potential safety hazard Structural defects apparent in superstructure	
COMMENTS: Brick; concrete; wood roof deck framing; old systems; seismic issues	
COMPONENT: Exterior Closure	RATING: 5 x WEIGHT: 8.3 = SCORE: 41.7
Significant deterioration, leaking and air infiltration apparent	
COMMENTS: Brick and concrete; deterioration throughout	
COMPONENT: Roofing	RATING: 3 x WEIGHT: 10.4 = SCORE: 31.3
Some deterioration is evident in membrane and flashings; maintenance or minor repair is needed	
COMMENTS: BUR v UV coat

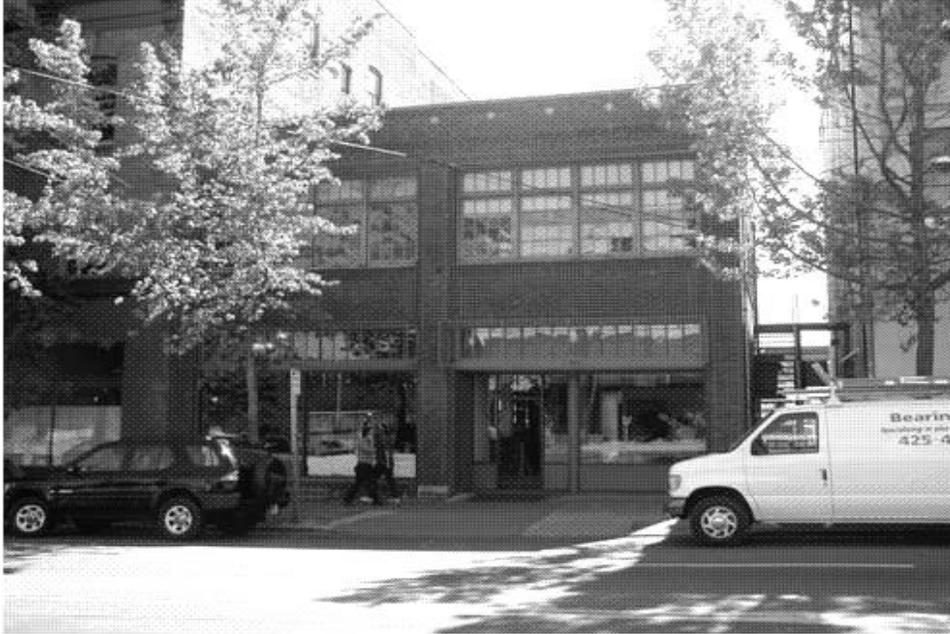
International Student Center (062-ISC) STATE UFI: A07934 Main Campus (062A)
 AREA: 3,760 SF BUILT: No data REMODELED: No PREDOMINANT USE: Multi-Use
 CONSTRUCTION TYPE: Medium CRV/SF: \$316 REPLACEMENT VALUE: \$1,188,160

Primary Systems	
COMPONENT: Structure	RATING: 3 x WEIGHT: 8 = SCORE: 24
Some cracking evident but does not likely affect structural integrity; Visible defects apparent but are non-structural	
COMMENTS: Concrete; brick; wood-framing	
COMPONENT: Exterior Closure	RATING: 3 x WEIGHT: 8 = SCORE: 24
Sound and weatherproof but with some deterioration evident	
COMMENTS: Brick-mortar repair and tuck-pointing needed	
COMPONENT: Roofing	RATING: 1 x WEIGHT: 10 = SCORE: 10
Flashing and penetrations appear sound and membrane appears water-tight; drainage is positive and there are overflow scuppers	
COMMENTS: BUR with mineral-surfaced cap sheet

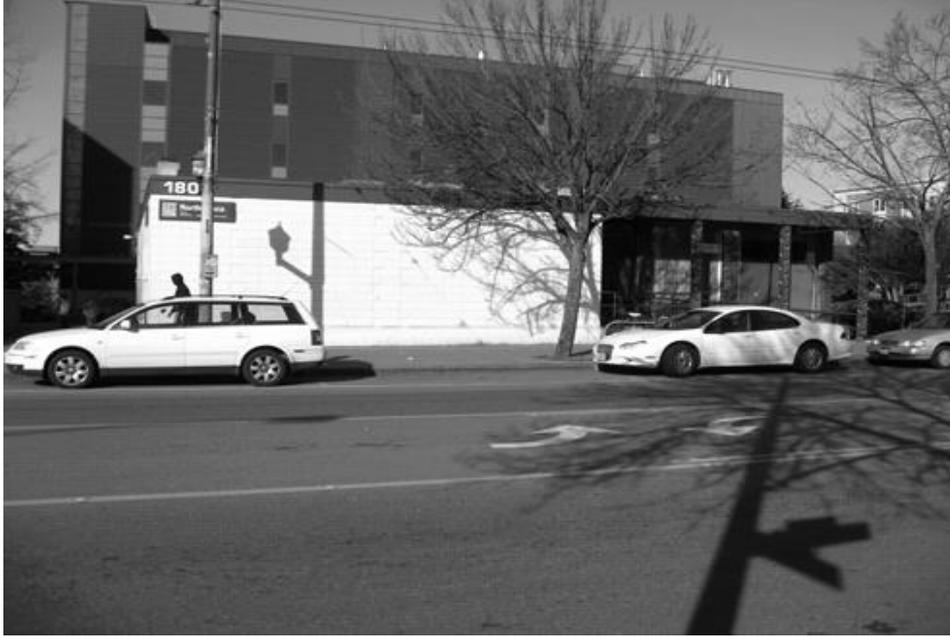
North Plaza (062-NP) STATE UFI: A08175 Main Campus (062A)
 AREA: 19,470 SF BUILT: No data REMODELED: No PREDOMINANT USE: Vocational Arts
 CONSTRUCTION TYPE: Medium CRV/SF: \$301 REPLACEMENT VALUE: \$5,860,470

Primary Systems	
COMPONENT: Structure	RATING: 5 x WEIGHT: 8 = SCORE: 40
Visible settlement and potential structural failure; potential safety hazard Structural defects apparent in superstructure	
COMMENTS: Concrete tilt-up panels; CMU; seismic issues	
COMPONENT: Exterior Closure	RATING: 3 x WEIGHT: 8 = SCORE: 24
Sound and weatherproof but with some deterioration evident	
COMMENTS: Concrete tilt-up panels; brick; CMU	
COMPONENT: Roofing	RATING: 5 x WEIGHT: 10 = SCORE: 50
Leaking and deterioration is to point where new roof is required	
COMMENTS: BUR membrane-leaks
