## STRUCTURAL EVALUATION FOR

# SEATTLE CENTRAL COLLEGE BROADWAY PERFORMANCE HALL SEATTLE, WASHINGTON

PREPARED BY  
PCS STRUCTURAL SOLUTIONS

NOVEMBER 1, 2017  
17-733

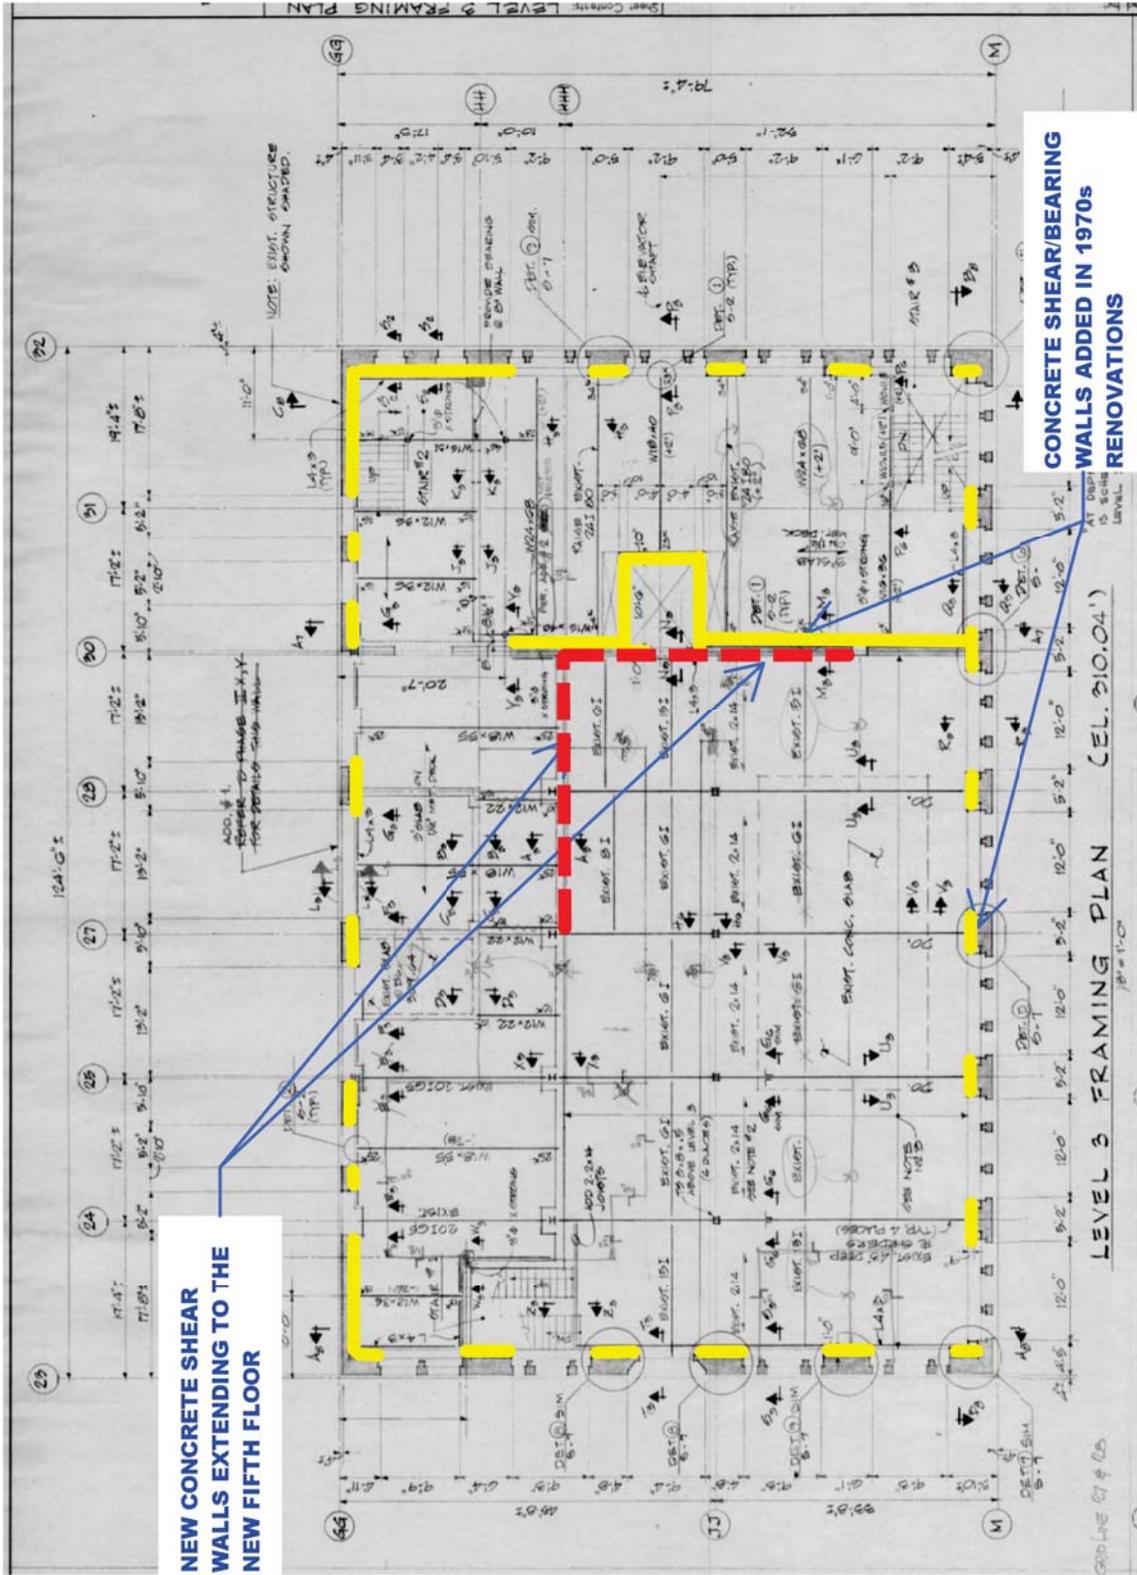
S2

**NEW CONCRETE SHEAR WALLS EXTENDING TO THE NEW FIFTH FLOOR**

**CONCRETE SHEAR/BEARING WALLS ADDED IN 1970s RENOVATIONS**

<b>Items</b>	<b>Structural Concern</b>	<b>Structural Recommendation</b>
1	The stress in the existing concrete walls will exceed allowable limits.	Provide new concrete walls and foundations at the interior of the building to keep the stresses transferred to the existing walls/piers at allowable levels. See Appendix A, Sheet 2.
2	Out of plane anchorage (connection of the wall to the floors) may not be sufficient in some areas.	Improve the connections by installing anchor bolts and steel braces at the perimeter of the floors.
3	Existing foundations may not have the capacity to support additional vertical loads.	Remove/replace existing foundations, or increase the size of existing footings. This will require shoring in some areas.
4	Existing columns may not have the capacity to support the floor addition.	Strengthen existing columns by welding on additional steel.

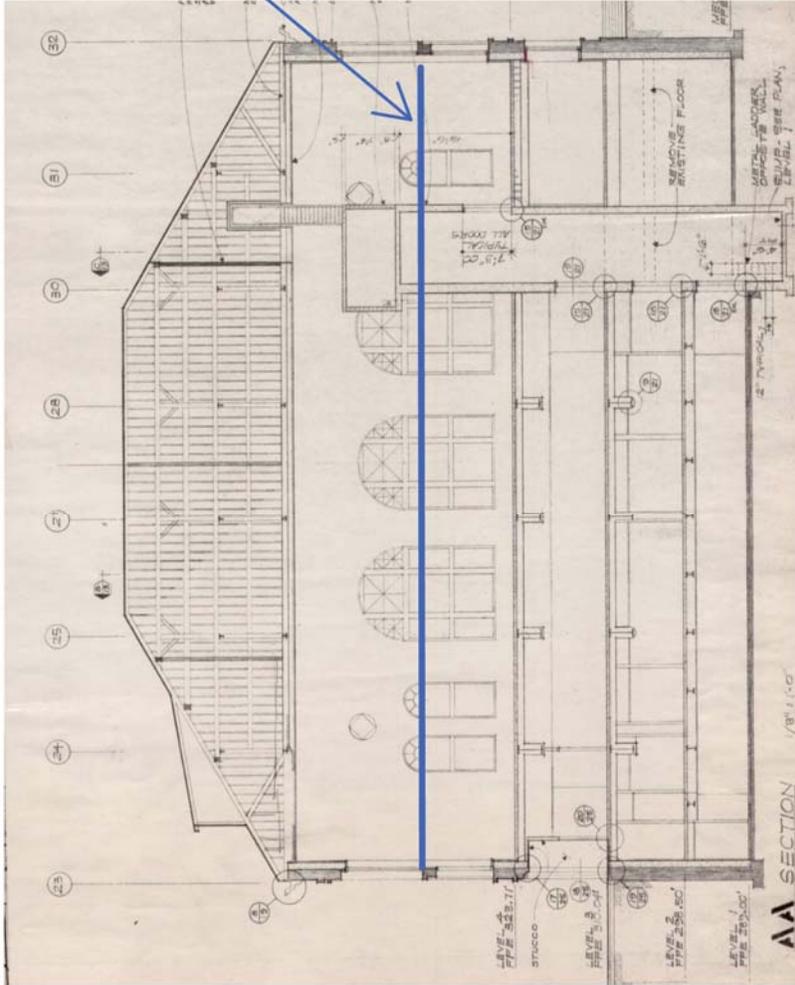
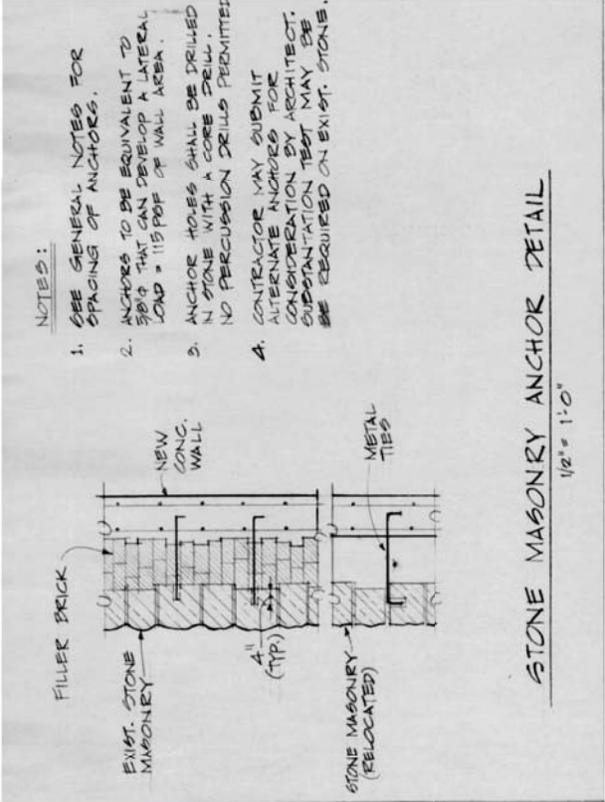
S3

POTENTIAL 5TH FLOOR ADDITION
