BROADWAY PERFORMANCE HALL DRAFT

EXTERIOR ENVELOPE CONDITIONS ASSESSMENT March 2016

Re: Broadway Performance Hall Masonry Consulting Project # 2065006

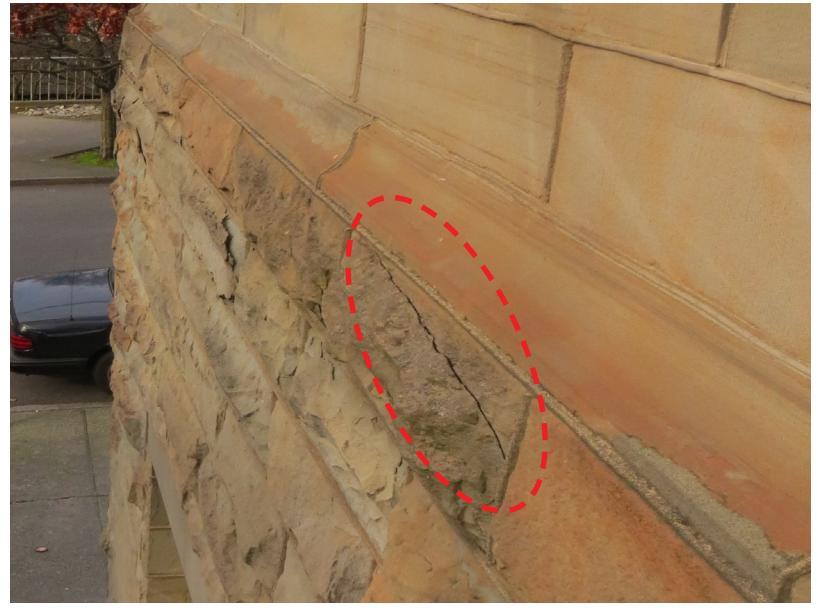
Fig. 1 Cracked Stone Over South Entrance (circled in red)

Spalled and crack stone on vertical faces of the building present a risk of dislodging from the building. This condition is present on the north, west, and south elevations, however the stone on the south elevation is significantly worse (See Fig. 1 & 2) and should be removed immediately. Stone at several window ledges have spalled at both vertical and skyfacing surfaces. Spalled stone at the skyfacing surfaces (Fig. 3 & 4) present a significant water infiltration risk as depressions in the stone inhibits positive drainage and increases the risk of water infiltration to the building interior. Spalled stone at skyfacing surfaces should be removed. The area should be patched with a restoration mortar back to the original profile. And, lastly, a mortar wash should be placed over the surface to promote positive drainage away from the building interior

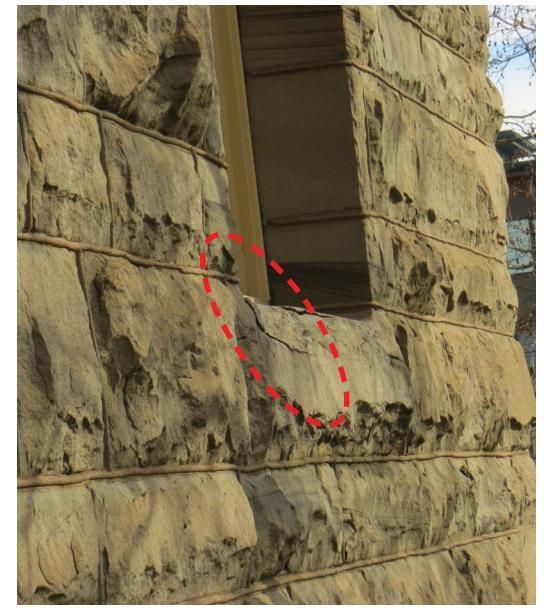
Fig. 2 Cracked Stone at South Elevation Window Sill (circled in red)

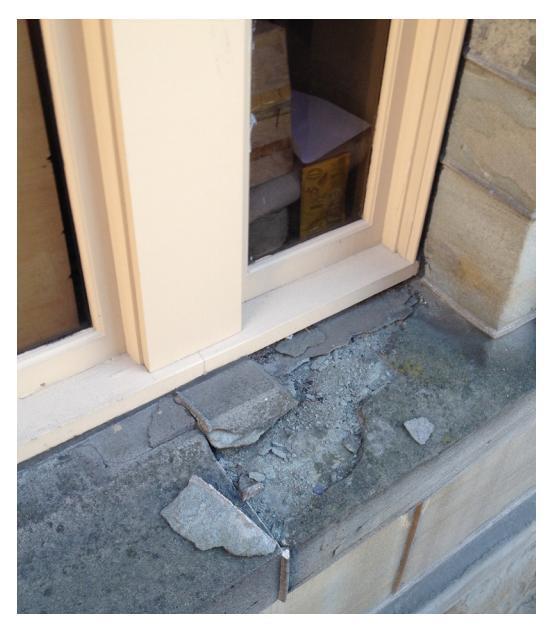
Fig. 3 Spalled Window Sill at North Elevation

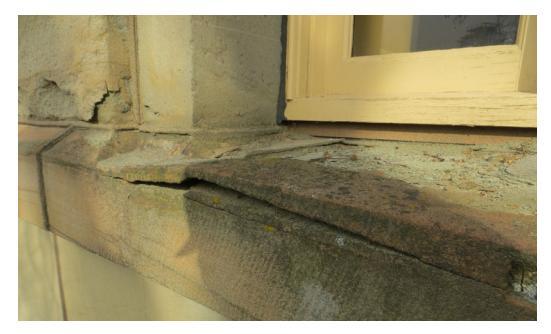
Fig. 4 Spalled Window Sill at North Elevation

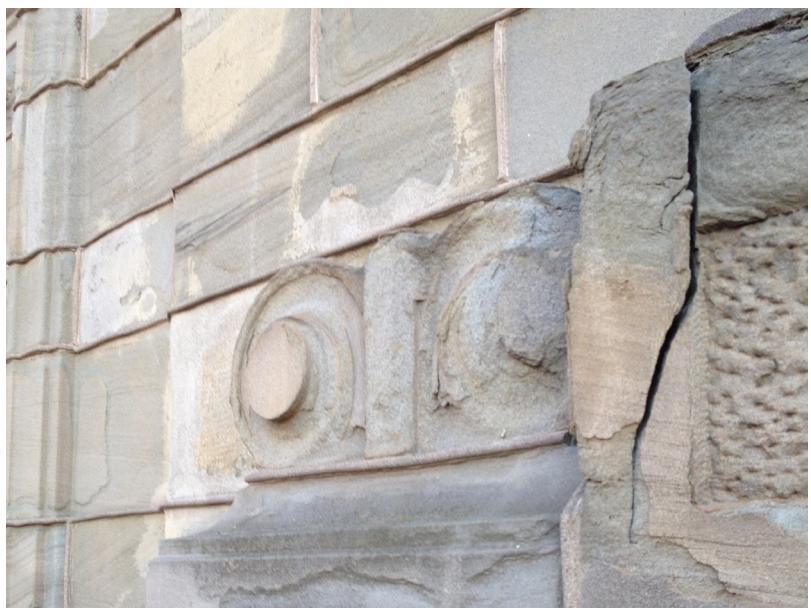
Fig. 5 Cracked Stone Frieze Above North Elevation Window Mantel

Large pieces of stone that have been removed or damaged (Fig. 5), should be replaced using a Dutchman technique.

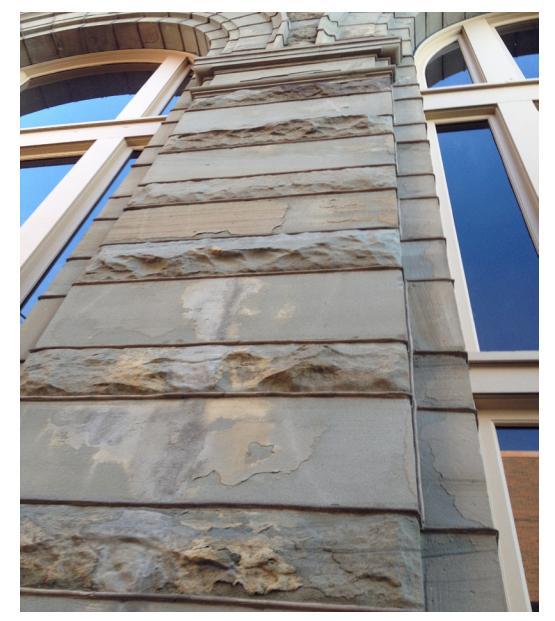
Fig. 6 Water unable to weep through mortar joints damages the stone surface

Mortar throughout the building is a hard cementitious type that, due to its strength, is causing damage to the adjacent stone (Fig. 6 & 7). The entire building should be repointed with a lime based mortar and tooled to match the historic beaded joint profile. Concurrently with repointing, surface exfoliation, a consequence of the surface sealers previously used, should be addressed. A masonry cleaning program, including low pressure water washing in addiiton to low pressure blasting using a soft blasting medium, is recommended to remove the loose friable material.

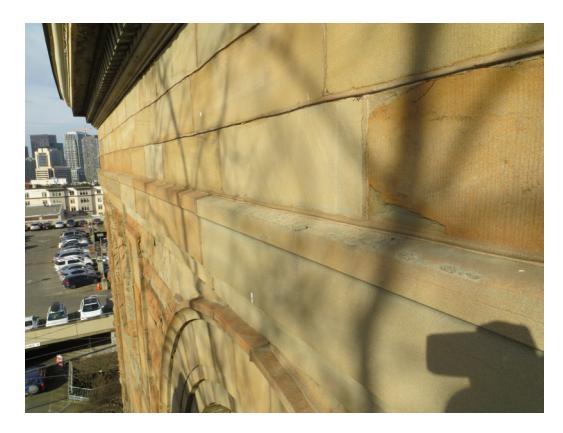
Fig. 7 Water unable to weep through mortar joints damages the stone surface

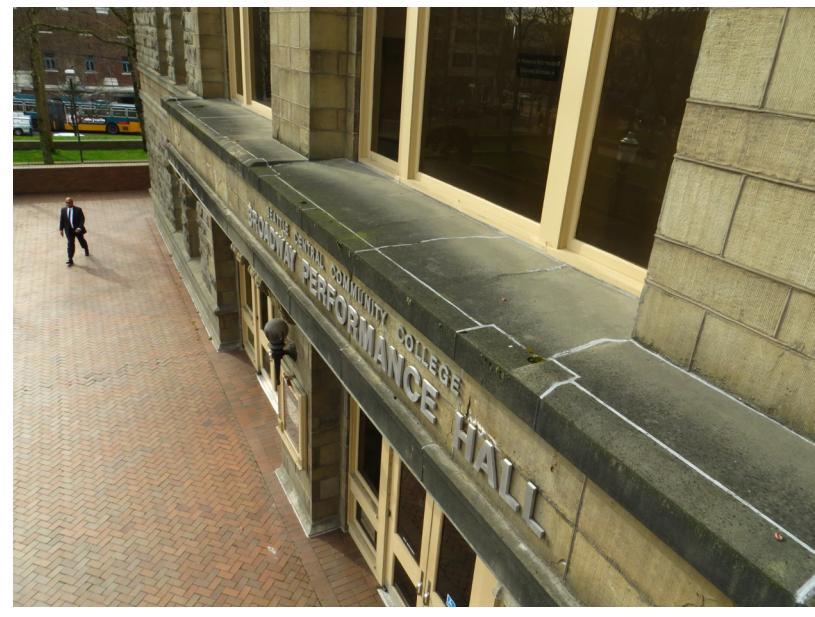
Fig. 8 Sealant joints over the east entry cornice

Fig. 9 Effloresence on the underside of the east entry cornice

Skyfacing joints present a greater risk than vertical joints, and if left unrepaired, could present a water infiltration risk. Where skyfacing joints exist over covered areas, such as the (main) east entrance (Fig. 8 & 9), use of a non-reflective metal cover (Fig. 10) may be considered to promote positive drainage of water away from the building in addition to protecting the stone from water infiltration through both the stone surface and mortar or sealant joints.

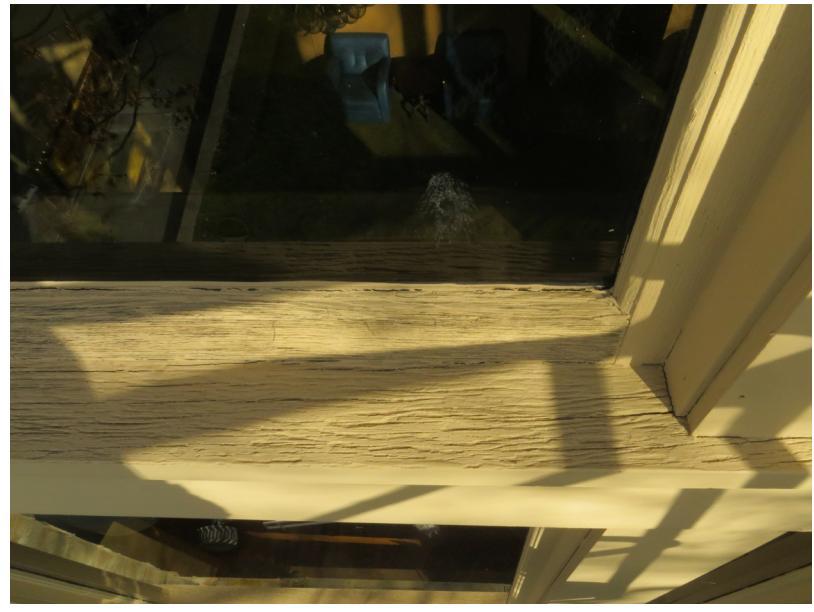
Fig. 11 Wood Window Sill on South Elevation Window

Wood sills on the north are in good condition. Wood sills on the east and west (Fig. 12 & 13) facing windows are showing signs of weathering due to age and lack of paint maintenance: raised grain, failed paint and some weather checking. Sills on the south facing windows (Fig. 11) show more advanced signs of weathering and are more likely candidates for dry rot.

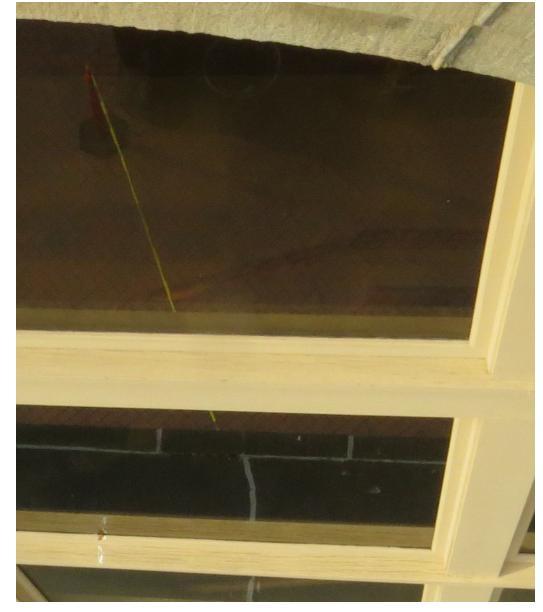
Fig. 12 Wood Window Sill on East Elevation Window

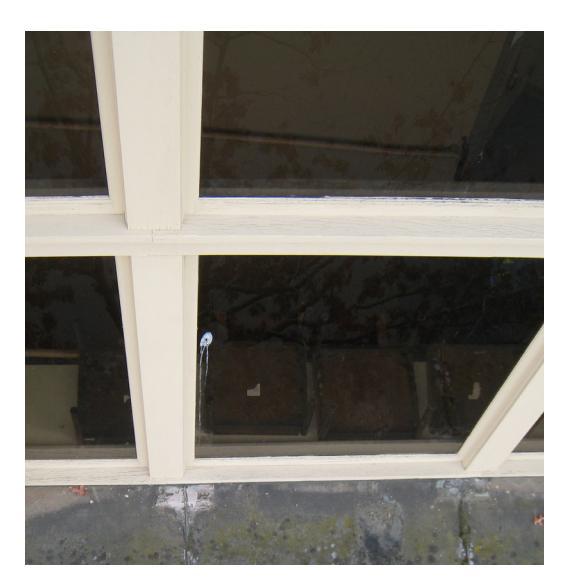
Fig. 13 Wood Window Sill on West Elevation Window

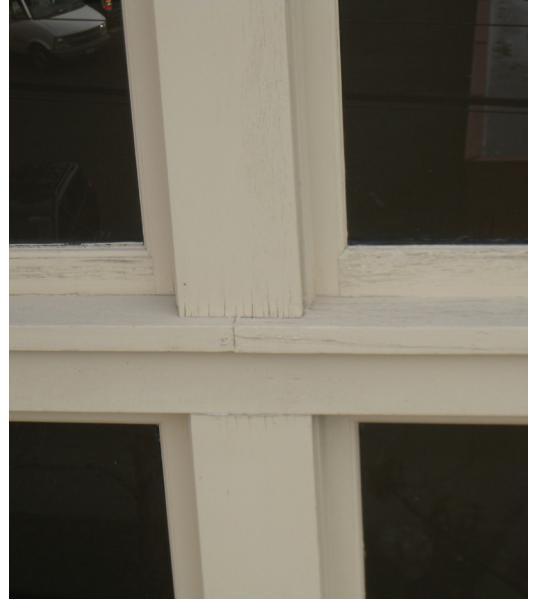
Fig. 14 Wood window Frame and Trim on West Elevation Window

towards the bottoms of frames where vertical components met horizontal skyfacing components (sills, trim,etc.). Wood window frames, trim and brickmold on the south and west (Fig. 14 & 15) facing windows show more advanced signs of weathering.

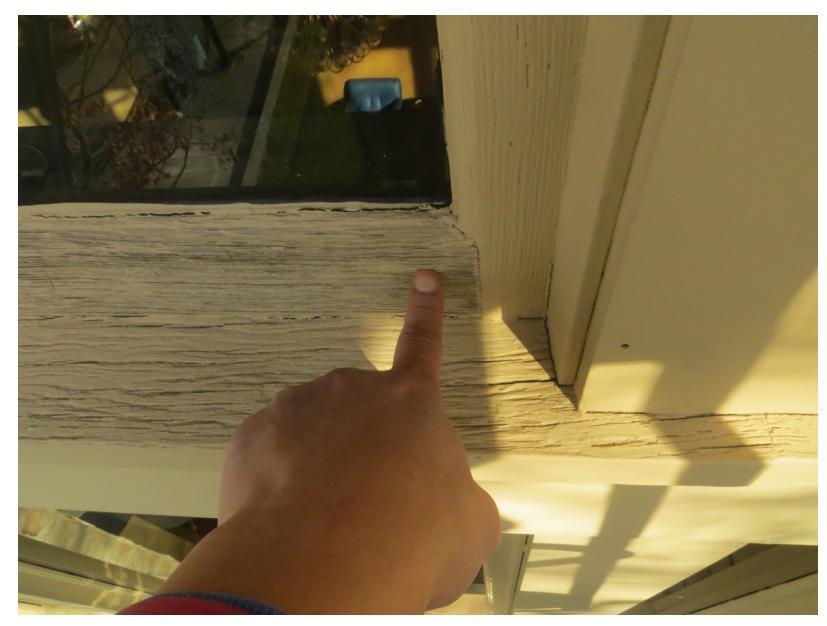
Fig. 15 Wood window Frame on South Elevation Window

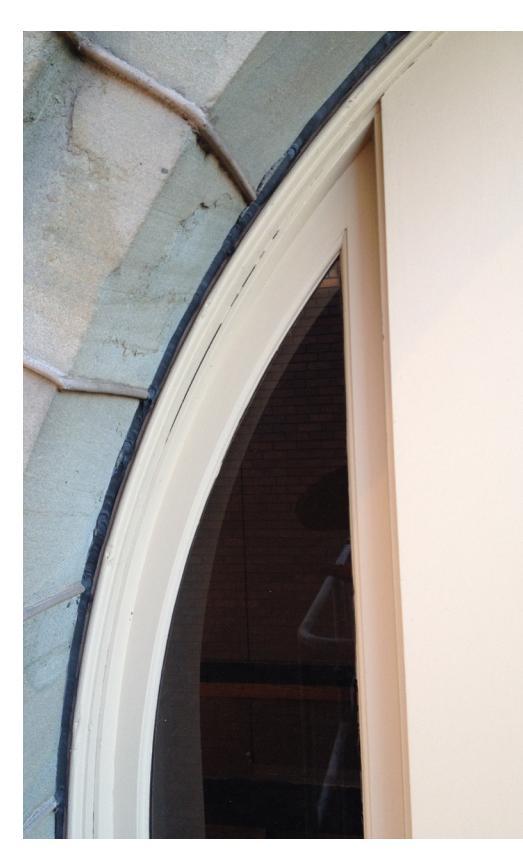
Fig. 16 Perimeter Sealant at Window Opening

Perimeter sealant throughout is well adhered and flexible and appears to be in good condition. It is however, unsightly. Perimeter sealant should be replaced with a sanded sealant, custom colored silicone sealant to match the wood windows, or a paintable urethane sealant.

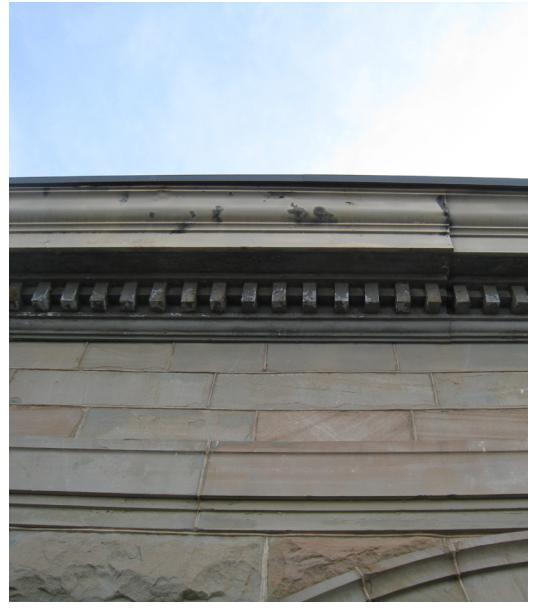
Fig. 18 Paint Failure at Ornamental Gutter Cover

The ornamental metal gutter cover, at roof level, exhibits signs of paint failure (Fig 18). In addition, it is detached in several locations. The cover should be removed, restored (including repainting), and reinstalled.

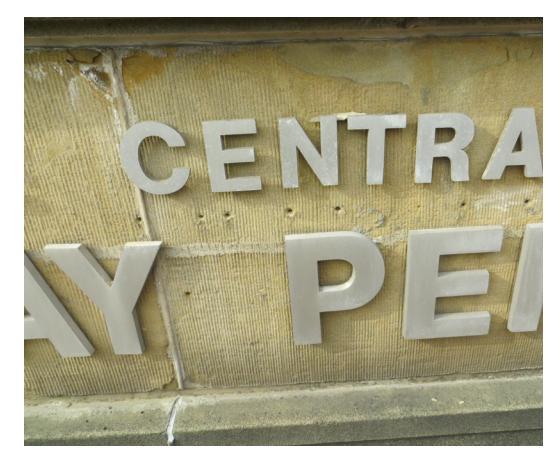
Fig. 20 Building Lettering on East Elevation

Building identification lettering (Fig. 20) should be modified to reflect the College's current name, "Seattle Central College" as opposed to "Seattle Central Community College". Existing abandoned dimensional-letter holes and new ones created by the rearrangement should be patched with a restoration mortar to match the existing adjacent stone.

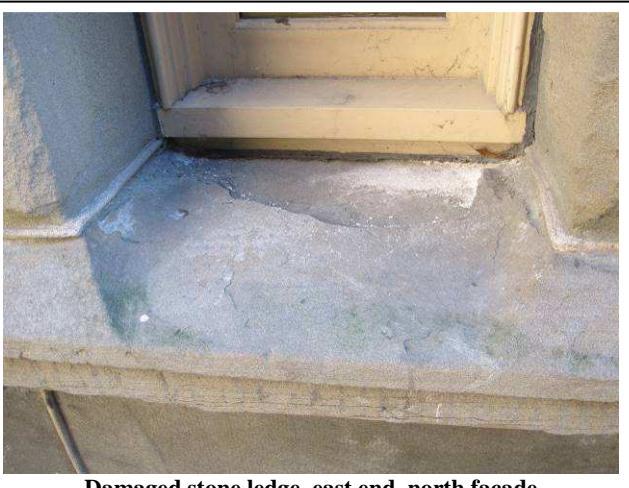
Damaged stone ledge, east end. north façade

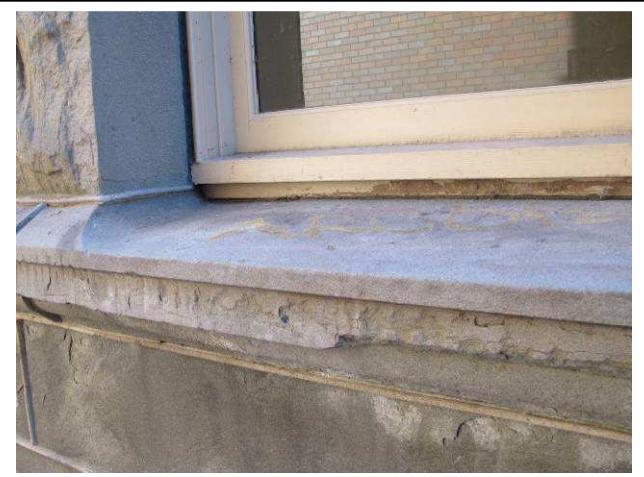
Spalling stone, east end, north façade

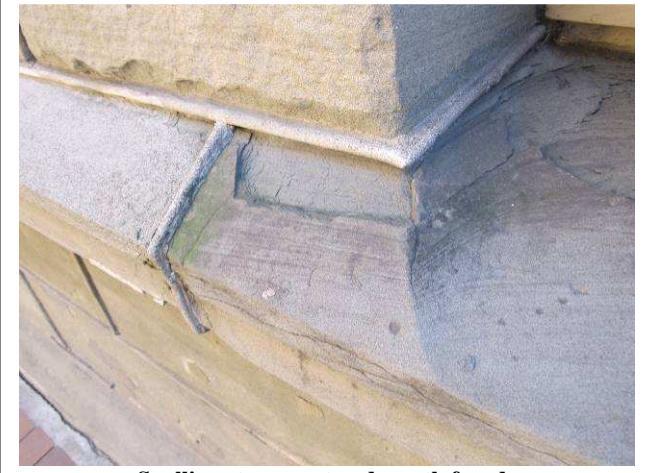
Spalling stone, east end, north façade
