2015 FACILITY CONDITION SURVEY

Seattle Central Community
College

SURVEY CONDUCTED BY:
Steve Lewandowski
State Board for Community
and Technical Colleges

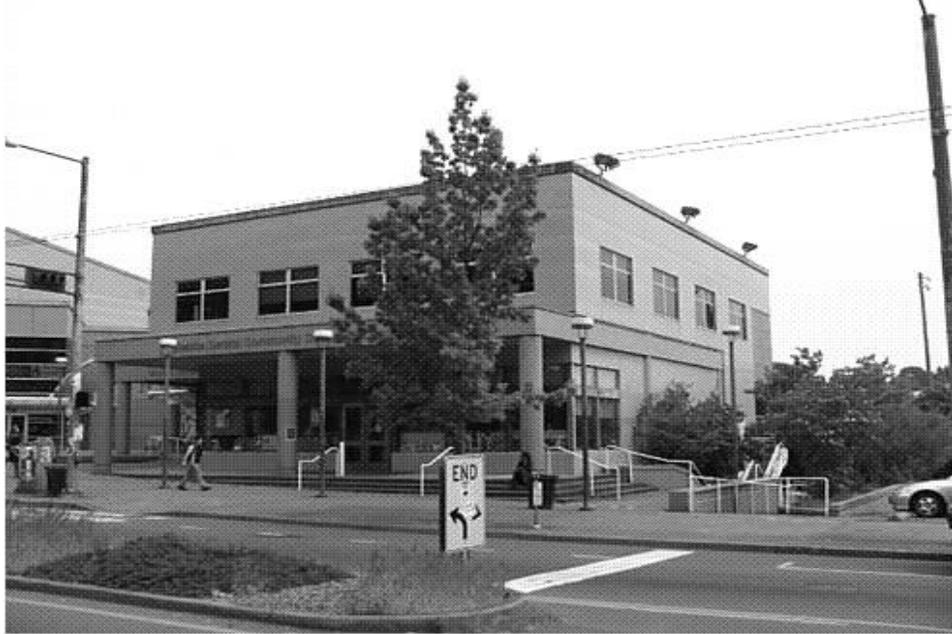
Bookstore (062-BS) STATE UFI: A01833 Main Campus (062A)
 AREA: 6,400 SF BUILT: 1994 REMODELED: No PREDOMINANT USE: Student Center
 CONSTRUCTION TYPE: Heavy CRV/SF: \$316 REPLACEMENT VALUE: \$2,022,400

Primary Systems	
COMPONENT: Structure	RATING: 1 x WEIGHT: 8 = SCORE: 8
No signs of settlement or cracking, no abrupt vertical changes Columns, bearing walls and roof structure appears sound/free of defects	
COMMENTS: Concrete structure	
COMPONENT: Exterior Closure	RATING: 1 x WEIGHT: 8 = SCORE: 8
Weatherproof, tight, well-maintained exterior walls, doors, windows/finishes	
COMMENTS: Concrete; ceramic tile	
COMPONENT: Roofing	RATING: 3 x WEIGHT: 10 = SCORE: 30
Some deterioration is evident in membrane and flashings; maintenance or minor repair is needed	
COMMENTS: Hypalon single-ply; BUR with mineral-surfaced capsheet

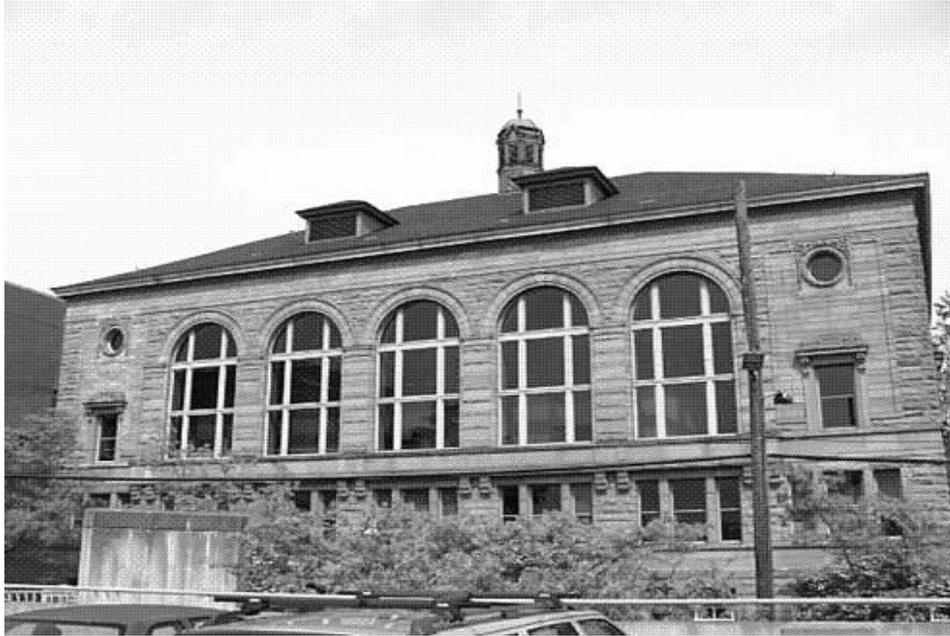
Broadway Performance Hall (062-BPH) STATE UFI: A02918 Main Campus (062A)
 AREA: 29,400 SF BUILT: 1977 REMODELED: 1978 PREDOMINANT USE: Performing Arts
 CONSTRUCTION TYPE: Heavy CRV/SF: \$337 REPLACEMENT VALUE: \$9,907,800

Primary Systems	
COMPONENT: Structure	RATING: 1 x WEIGHT: 8 = SCORE: 8
No signs of settlement or cracking, no abrupt vertical changes Columns, bearing walls and roof structure appears sound/free of defects	
COMMENTS: Structural steel frame; heavy timber roof trusses	
COMPONENT: Exterior Closure	RATING: 3 x WEIGHT: 8 = SCORE: 24
Sound and weatherproof but with some deterioration evident	
COMMENTS: Historic "Wilkerson Sandstone" (not sealed)	
COMPONENT: Roofing	RATING: 1 x WEIGHT: 10 = SCORE: 10
Flashing and penetrations appear sound and membrane appears water- tight; drainage is positive and there are overflow scuppers	
COMMENTS: Composition 3-tab shingles-2003

Secondary Systems		
COMPONENT:	Floor Finishes	RATING: 3 x WEIGHT: 6 = SCORE: 18
Some wear and minor imperfections are evident; beginning deterioration		
COMMENTS:	Wood parquet and strip flooring; carpet-stained; ceramic tile; concrete; linoleum; Vinyl tile-surface wear	
COMPONENT:	Wall Finishes	RATING: 3 x WEIGHT: 6 = SCORE: 18
Aging surfaces but sound; some maintenance is required		
COMMENTS:	Gypsum board-marred/surface wear; ceramic tile; acoustical panels	
COMPONENT:	Ceiling Finishes	RATING: 3 x WEIGHT: 6 = SCORE: 18
Some wear and tear; Minor staining or deterioration		
COMMENTS:	Gypsum board; suspended wood-lattice panels; lay-in and direct-adhered tile	
COMPONENT:	Doors & Hardware	RATING: 1 x WEIGHT: 6 = SCORE: 6
Appropriate hardware, closers, panic devices; in good working order		
COMMENTS:	Interior wood/HM doors/frames; exterior wood doors/frames

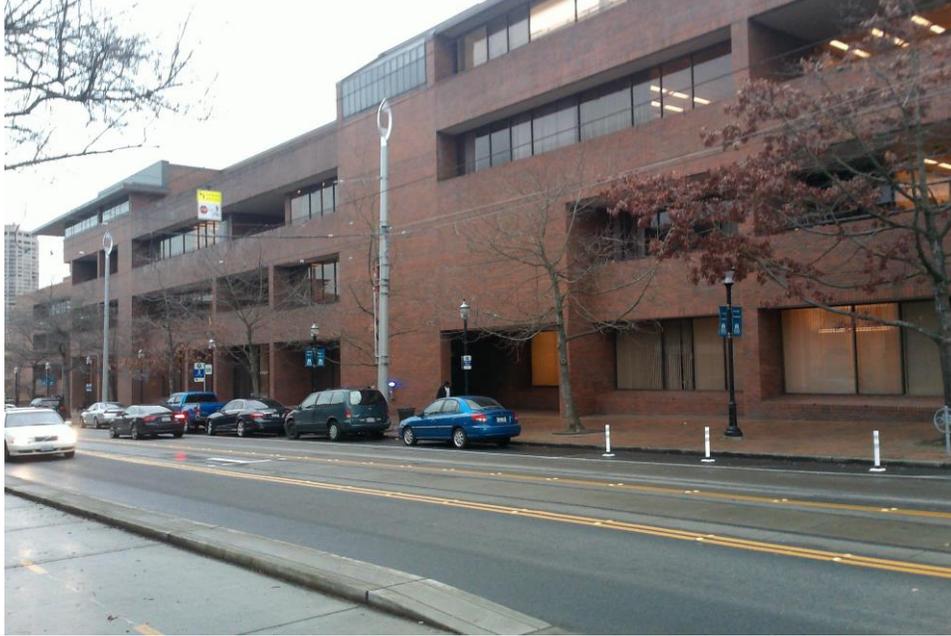
Broadway/Edison (062-BE) STATE UFI: A02501 Main Campus (062A)
 AREA: 442,984 SF BUILT: 1973 REMODELED: 1993 PREDOMINANT USE: Multi-Use
 CONSTRUCTION TYPE: Heavy CRV/SF: \$316 REPLACEMENT VALUE: \$13,998,294

Primary Systems	
COMPONENT: Structure	RATING: 1 x WEIGHT: 8 = SCORE: 8
No signs of settlement or cracking, no abrupt vertical changes Columns, bearing walls and roof structure appears sound/free of defects	
COMMENTS: Partial concrete frame, partial heavy timber	
COMPONENT: Exterior Closure	RATING: 1 x WEIGHT: 8 = SCORE: 8
Weatherproof, tight, well-maintained exterior walls, doors, windows/finishes	
COMMENTS: Stucco-major renovation in 2010	
COMPONENT: Roofing	RATING: 1 x WEIGHT: 10 = SCORE: 10
Flashing and penetrations appear sound and membrane appears water- tight; drainage is positive and there are overflow scuppers	
COMMENTS: PVC single-ply membrane-2010

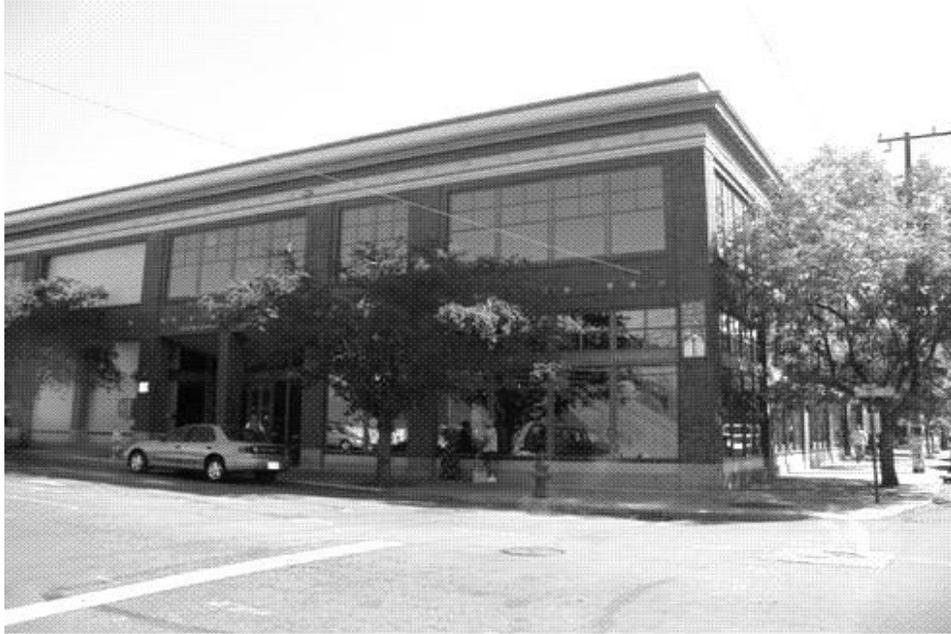
District Office (062-AS) STATE UFI: A00438 Main Campus (062A)
 AREA: 47,668 SF BUILT: No data REMODELED: 1990 PREDOMINANT USE: Administration
 CONSTRUCTION TYPE: Heavy CRV/SF: \$269 REPLACEMENT VALUE: \$12,822,692

Primary Systems		
COMPONENT:	Structure	RATING: 1 x WEIGHT: 8 = SCORE: 8
No signs of settlement or cracking, no abrupt vertical changes Columns, bearing walls and roof structure appears sound/free of defects		
COMMENTS:	Concrete; heavy timber; steel-frame; wood framing	
COMPONENT:	Exterior Closure	RATING: 1 x WEIGHT: 8 = SCORE: 8
Weatherproof, tight, well-maintained exterior walls, doors, windows/finishes		
COMMENTS:	Brick with concrete base; ceramic tile	
COMPONENT:	Roofing	RATING: 5 x WEIGHT: 10 = SCORE: 50
Leaking and deterioration is to point where new roof is required		
COMMENTS:	Hypalon single-ply membrane; Kalwall skylights

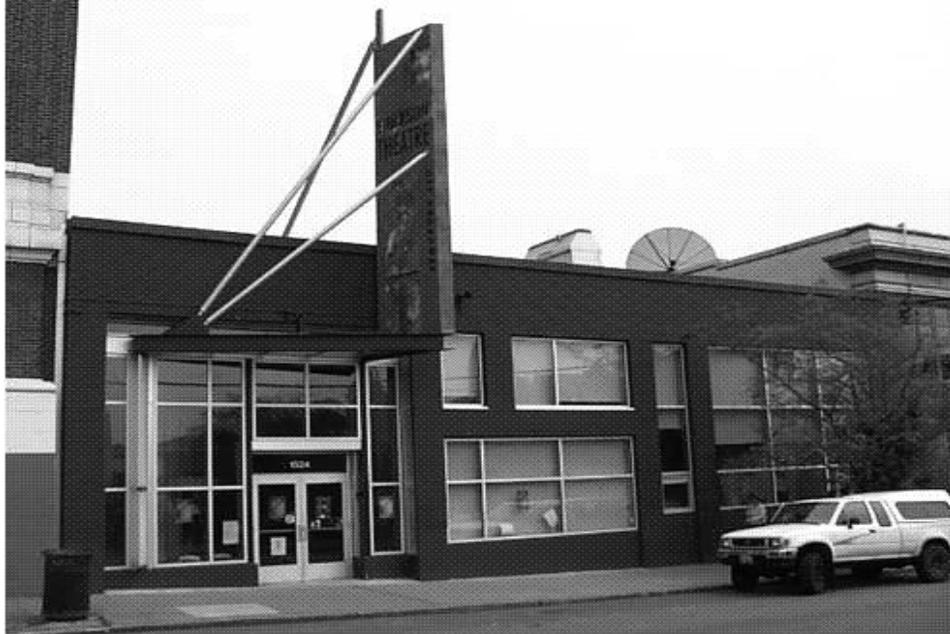
Erickson Theater (062-ET) STATE UFI: A09728 Main Campus (062A)
 AREA: 11,500 SF BUILT: No data REMODELED: 2004 PREDOMINANT USE: Performing Arts
 CONSTRUCTION TYPE: Medium CRV/SF: \$337 REPLACEMENT VALUE: \$3,875,500

Primary Systems	
COMPONENT: Structure	RATING: 1 x WEIGHT: 8.3 = SCORE: 8.3
No signs of settlement or cracking, no abrupt vertical changes Columns, bearing walls and roof structure appears sound/free of defects	
COMMENTS: Wood frame; heavy timber trusses and beams; steel columns; seismic improvements done	
COMPONENT: Exterior Closure	RATING: 1 x WEIGHT: 8.3 = SCORE: 8.3
Weatherproof, tight, well-maintained exterior walls, doors, windows/finishes	
COMMENTS: Brick; concrete; glass block; CMU	
COMPONENT: Roofing	RATING: 1 x WEIGHT: 10.4 = SCORE: 10.4
Flashing and penetrations appear sound and membrane appears water- tight; drainage is positive and there are overflow scuppers	
COMMENTS: BUR with mineral-surfaced cap sheet

Secondary Systems			
COMPONENT:	Floor Finishes	RATING: 1 x WEIGHT: 6.3 =	SCORE: 6.3
Nice appearance, smooth transitions, level subfloors, no cracks/separating			
COMMENTS:	Concrete; carpet; rubber stage floor		
COMPONENT:	Wall Finishes	RATING: 1 x WEIGHT: 6.3 =	SCORE: 6.3
Maintainable surfaces in good condition			
COMMENTS:	Gypsum board; corrugated plastic panels; painted concrete; CMU		
COMPONENT:	Ceiling Finishes	RATING: 1 x WEIGHT: 6.3 =	SCORE: 6.3
Maintainable surfaces in good condition; good alignment and appearance			
COMMENTS:	Gypsum board; exposed structure; suspended corrugated plastic panels (Kalwall)		
COMPONENT:	Doors & Hardware	RATING: 1 x WEIGHT: 6.3 =	SCORE: 6.3
Appropriate hardware, closers, panic devices; in good working order			
COMMENTS:	Interior wood/HM doors w HM frames; exterior aluminum doors/frames; metal coiling door

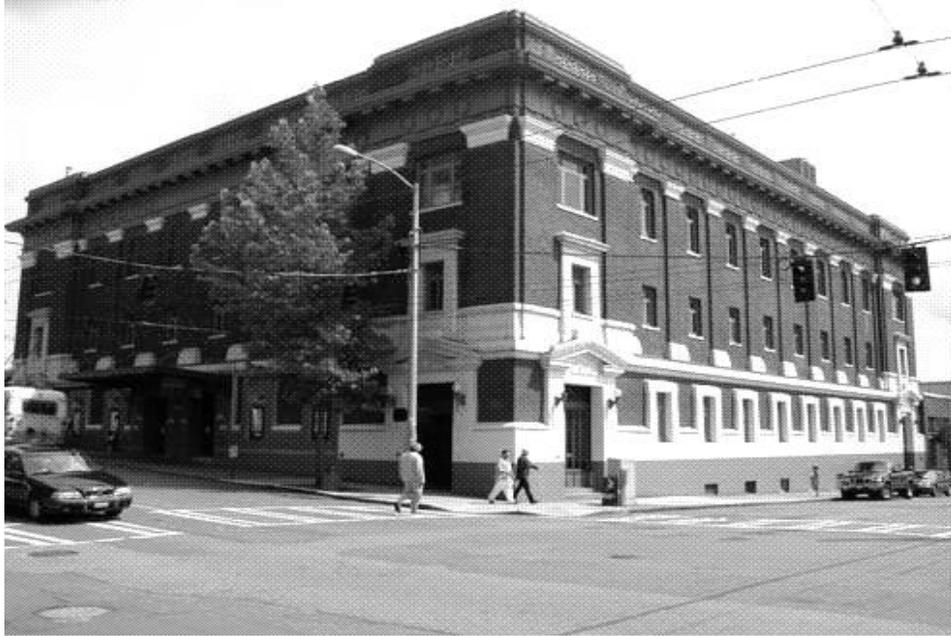
Fine Arts Building (062-FA) STATE UFI: A07769 Main Campus (062A)
 AREA: 64,820 SF BUILT: No data REMODELED: 1997 PREDOMINANT USE: Visual Arts
 CONSTRUCTION TYPE: Heavy CRV/SF: \$337 REPLACEMENT VALUE: \$21,844,340

Primary Systems	
COMPONENT: Structure	RATING: 1 x WEIGHT: 8 = SCORE: 8
No signs of settlement or cracking, no abrupt vertical changes Columns, bearing walls and roof structure appears sound/free of defects	
COMMENTS: Concrete structure	
COMPONENT: Exterior Closure	RATING: 3 x WEIGHT: 8 = SCORE: 24
Sound and weatherproof but with some deterioration evident	
COMMENTS: Brick; sheet metal coping & frieze; concrete block	
COMPONENT: Roofing	RATING: 1 x WEIGHT: 10 = SCORE: 10
Flashing and penetrations appear sound and membrane appears water-tight; drainage is positive and there are overflow scuppers	
COMMENTS: BUR with mineral-surfaced capsheet; standing seam metal

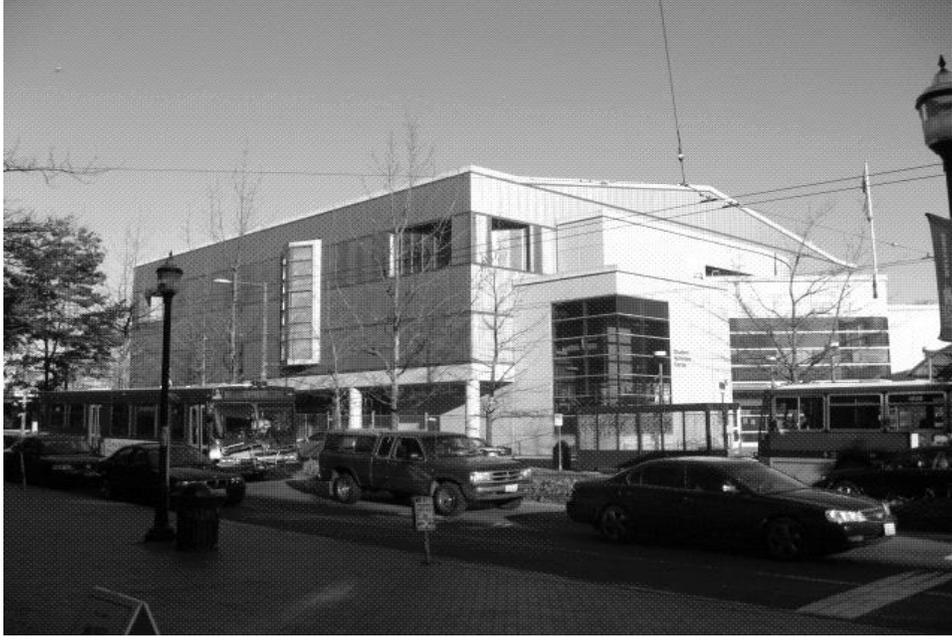
Mitchell Activity Center (062-MAC) STATE UFI: A06198 Main Campus (062A)
 AREA: 78,600 SF BUILT: 1994 REMODELED: No PREDOMINANT USE: Gymnasium
 CONSTRUCTION TYPE: Heavy CRV/SF: \$279 REPLACEMENT VALUE: \$21,929,400

Primary Systems	
COMPONENT: Structure	RATING: 1 x WEIGHT: 8 = SCORE: 8
No signs of settlement or cracking, no abrupt vertical changes Columns, bearing walls and roof structure appears sound/free of defects	
COMMENTS: Concrete; steel frame	
COMPONENT: Exterior Closure	RATING: 1 x WEIGHT: 8 = SCORE: 8
Weatherproof, tight, well-maintained exterior walls, doors, windows/finishes	
COMMENTS: Concrete; corrugated metal panels	
COMPONENT: Roofing	RATING: 1 x WEIGHT: 10 = SCORE: 10
Flashing and penetrations appear sound and membrane appears water- tight; drainage is positive and there are overflow scuppers	
COMMENTS: BUR with mineral-surfaced capsheet; standing seam metal

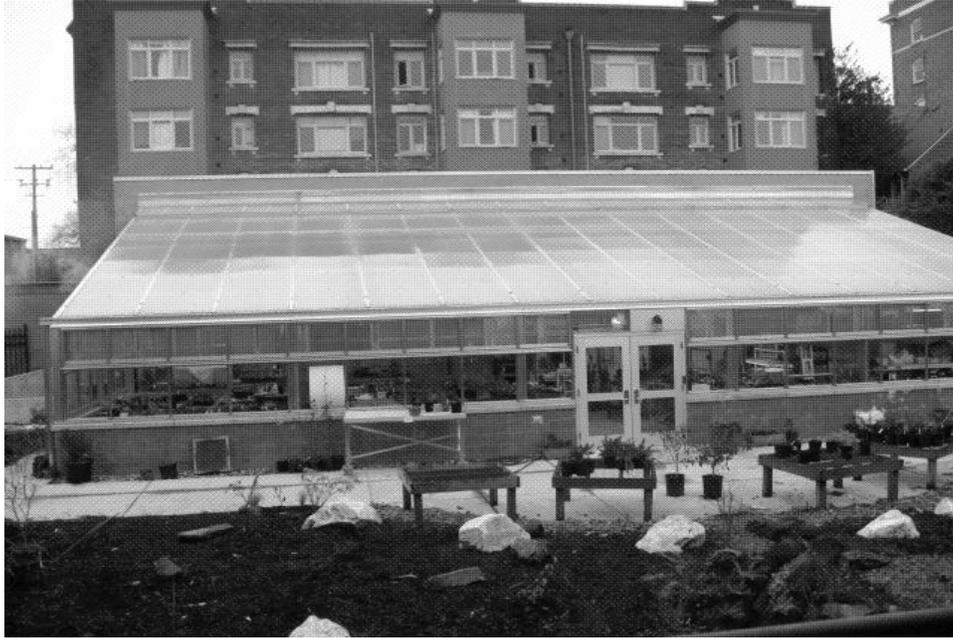
Plant Sciences Lab (062-PSL) STATE UFI: A10698 Main Campus (062A)
 AREA: 1,827 SF BUILT: 2010 REMODELED: No PREDOMINANT USE: Greenhouse
 CONSTRUCTION TYPE: Medium CRV/SF: \$395 REPLACEMENT VALUE: \$721,665

Primary Systems	
COMPONENT: Structure	RATING: 1 x WEIGHT: 8.3 = SCORE: 8.3
No signs of settlement or cracking, no abrupt vertical changes Columns, bearing walls and roof structure appears sound/free of defects	
COMMENTS: Aluminum frame; CMU	
COMPONENT: Exterior Closure	RATING: 1 x WEIGHT: 8.3 = SCORE: 8.3
Weatherproof, tight, well-maintained exterior walls, doors, windows/finishes	
COMMENTS: Glass panels; CMU	
COMPONENT: Roofing	RATING: 1 x WEIGHT: 10.4 = SCORE: 10.4
Flashing and penetrations appear sound and membrane appears water- tight; drainage is positive and there are overflow scuppers	
COMMENTS: Polycarbonate panels

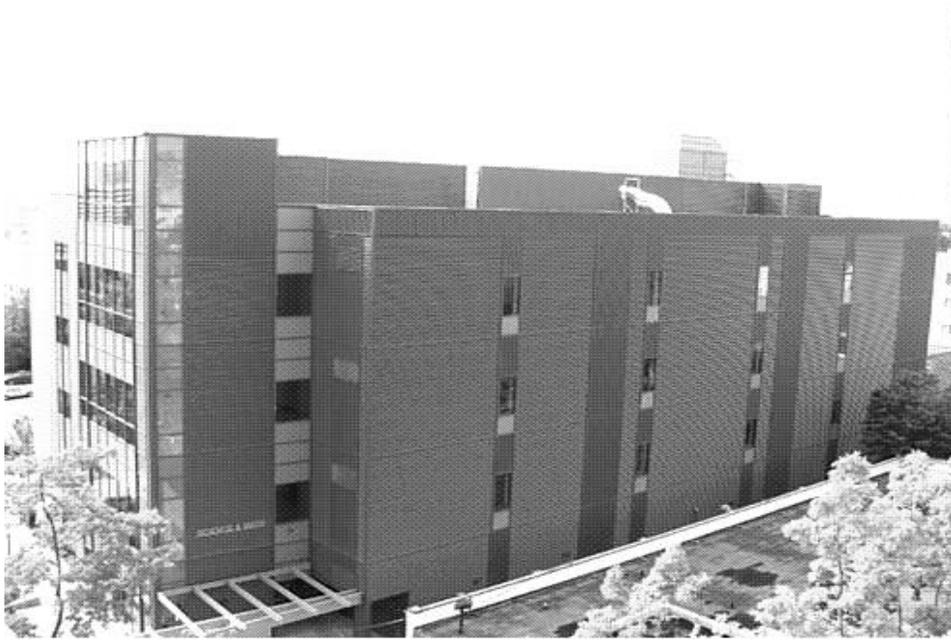
Science And Math (062-SAM) STATE UFI: A03954 Main Campus (062A)
 AREA: 84,300 SF BUILT: 2006 REMODELED: No PREDOMINANT USE: Science Lab.
 CONSTRUCTION TYPE: Heavy CRV/SF: \$391 REPLACEMENT VALUE: \$32,961,300

Primary Systems	
COMPONENT: Structure	RATING: 1 x WEIGHT: 8 = SCORE: 8
No signs of settlement or cracking, no abrupt vertical changes Columns, bearing walls and roof structure appears sound/free of defects	
COMMENTS: Steel frame	
COMPONENT: Exterior Closure	RATING: 1 x WEIGHT: 8 = SCORE: 8
Weatherproof, tight, well-maintained exterior walls, doors, windows/finishes	
COMMENTS: Brick; corrugated and flat metal panels	
COMPONENT: Roofing	RATING: 1 x WEIGHT: 10 = SCORE: 10
Flashing and penetrations appear sound and membrane appears water- tight; drainage is positive and there are overflow scuppers	
COMMENTS: BUR membrane with aluminum UV coating

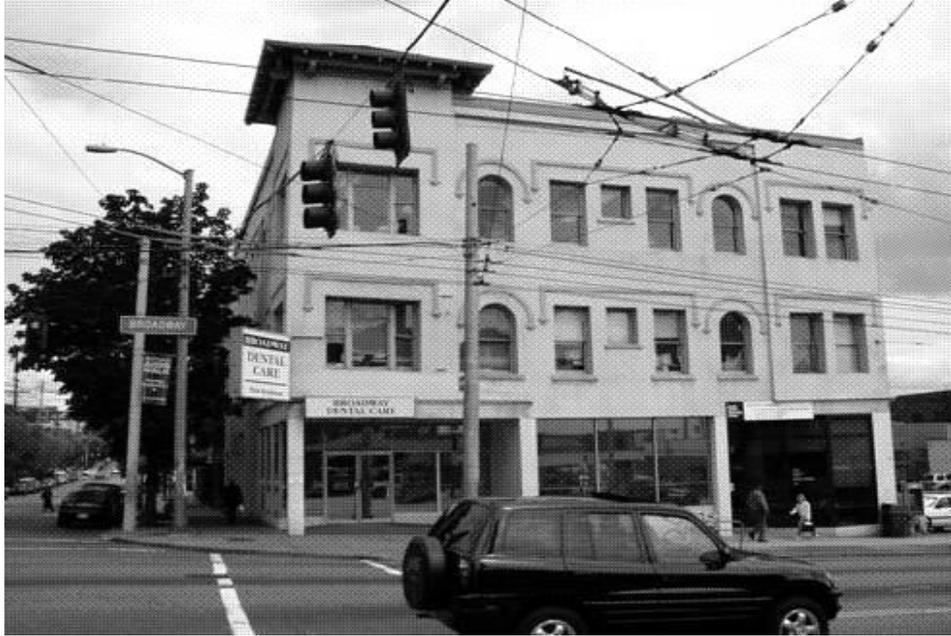
South Annex (062-SA) STATE UFI: A05447 Main Campus (062A)
 AREA: 14,800 SF BUILT: No data REMODELED: 1985 PREDOMINANT USE: General Classroom
 CONSTRUCTION TYPE: Medium CRV/SF: \$301 REPLACEMENT VALUE: \$4,454,800

Primary Systems	
COMPONENT: Structure	RATING: 3 x WEIGHT: 8 = SCORE: 24
Some cracking evident but does not likely affect structural integrity; Visible defects apparent but are non-structural	
COMMENTS: Concrete; wood-frame; masonry	
COMPONENT: Exterior Closure	RATING: 1 x WEIGHT: 8 = SCORE: 8
Weatherproof, tight, well-maintained exterior walls, doors, windows/finishes	
COMMENTS: Brick with stucco coat	
COMPONENT: Roofing	RATING: 1 x WEIGHT: 10 = SCORE: 10
Flashing and penetrations appear sound and membrane appears water-tight; drainage is positive and there are overflow scuppers	
COMMENTS: BUR with mineral-surfaced capsheet; composition shingles

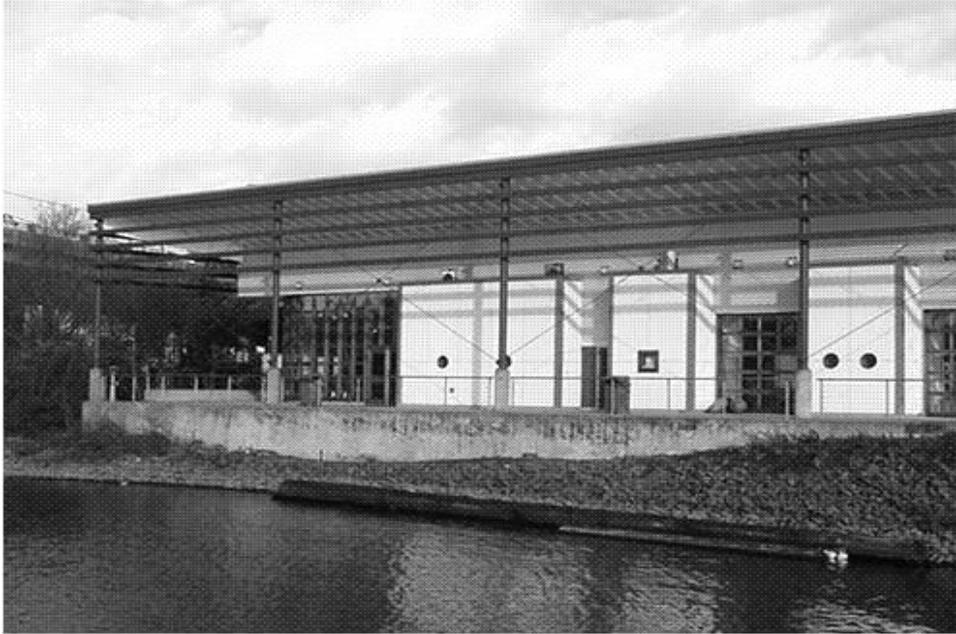
Marine Tech (062-SMAC) STATE UFI: A02017 Trident Campus (062C)
 AREA: 7,560 SF BUILT: 1987 REMODELED: No PREDOMINANT USE: Vocational Arts
 CONSTRUCTION TYPE: Medium CRV/SF: \$316 REPLACEMENT VALUE: \$2,388,960

Primary Systems	
COMPONENT: Structure	RATING: 1 x WEIGHT: 8.3 = SCORE: 8.3
No signs of settlement or cracking, no abrupt vertical changes Columns, bearing walls and roof structure appears sound/free of defects	
COMMENTS: Wood frame; CMU	
COMPONENT: Exterior Closure	RATING: 1 x WEIGHT: 8.3 = SCORE: 8.3
Weatherproof, tight, well-maintained exterior walls, doors, windows/finishes	
COMMENTS: Plywood and metal corrugated panels; glass window walls	
COMPONENT: Roofing	RATING: 3 x WEIGHT: 10.4 = SCORE: 31.3
Some deterioration is evident in membrane and flashings; maintenance or minor repair is needed	
COMMENTS: Metal screw-down roof panels-rusting/popping of screws; needs PVC overlay

Secondary Systems			
COMPONENT:	Floor Finishes	RATING: 3 x WEIGHT: 6.3 =	SCORE: 18.8
Some wear and minor imperfections are evident; beginning deterioration			
COMMENTS:	Concrete and vinyl tile-surface wear		
COMPONENT:	Wall Finishes	RATING: 3 x WEIGHT: 6.3 =	SCORE: 18.8
Aging surfaces but sound; some maintenance is required			
COMMENTS:	Gypsum board-marred; plywood		
COMPONENT:	Ceiling Finishes	RATING: 1 x WEIGHT: 6.3 =	SCORE: 6.3
Maintainable surfaces in good condition; good alignment and appearance			
COMMENTS:	Exposed roof structure; gypsum board		
COMPONENT:	Doors & Hardware	RATING: 3 x WEIGHT: 6.3 =	SCORE: 18.8
Functional but dated			
COMMENTS:	Wood glazed doors w HM frames-surface wear; wood glazed OH doors

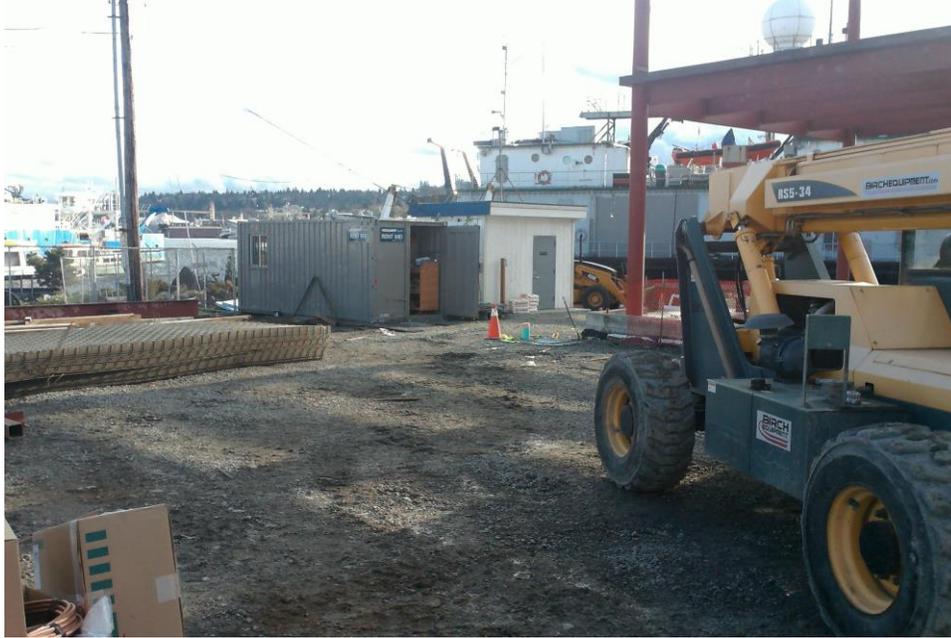
Marine Tech Mechanical Bd (062-SMAM) STATE UFI: A02929 Trident Campus (062C)
 AREA: 273 SF BUILT: No data REMODELED: No data PREDOMINANT USE: No data
 CONSTRUCTION TYPE: Light CRV/SF: \$0 REPLACEMENT VALUE: \$273

Primary Systems	
COMPONENT: Structure	RATING: 1 x WEIGHT: 11.1 = SCORE: 11.1
No signs of settlement or cracking, no abrupt vertical changes Columns, bearing walls and roof structure appears sound/free of defects	
COMMENTS: No data	
COMPONENT: Exterior Closure	RATING: 1 x WEIGHT: 11.1 = SCORE: 11.1
Weatherproof, tight, well-maintained exterior walls, doors, windows/finishes	
COMMENTS: No data	
COMPONENT: Roofing	RATING: 3 x WEIGHT: 13.9 = SCORE: 41.7
Some deterioration is evident in membrane and flashings; maintenance or minor repair is needed	
COMMENTS: No data

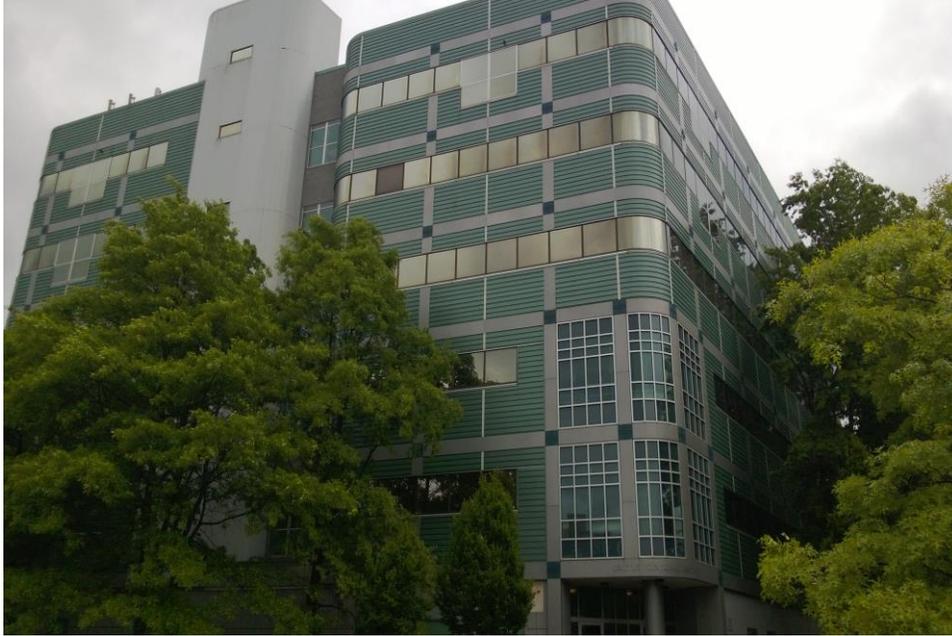
Seattle Vocational Inst. (065-SVI) STATE UFI: A05954 Vocational Institute (065A)
 AREA: 114,000 SF BUILT: 1991 REMODELED: 1996 PREDOMINANT USE: Vocational Arts
 CONSTRUCTION TYPE: Heavy CRV/SF: \$301 REPLACEMENT VALUE: \$34,314,000

Primary Systems	
COMPONENT: Structure	RATING: 1 x WEIGHT: 8 = SCORE: 8
No signs of settlement or cracking, no abrupt vertical changes Columns, bearing walls and roof structure appears sound/free of defects	
COMMENTS: Structural steel and cast concrete	
COMPONENT: Exterior Closure	RATING: 1 x WEIGHT: 8 = SCORE: 8
Weatherproof, tight, well-maintained exterior walls, doors, windows/finishes	
COMMENTS: Horizontal metal siding and aluminum building panels	
COMPONENT: Roofing	RATING: 3 x WEIGHT: 10 = SCORE: 30
Some deterioration is evident in membrane and flashings; maintenance or minor repair is needed	
COMMENTS: BUR with mineral-surfaced capsheet

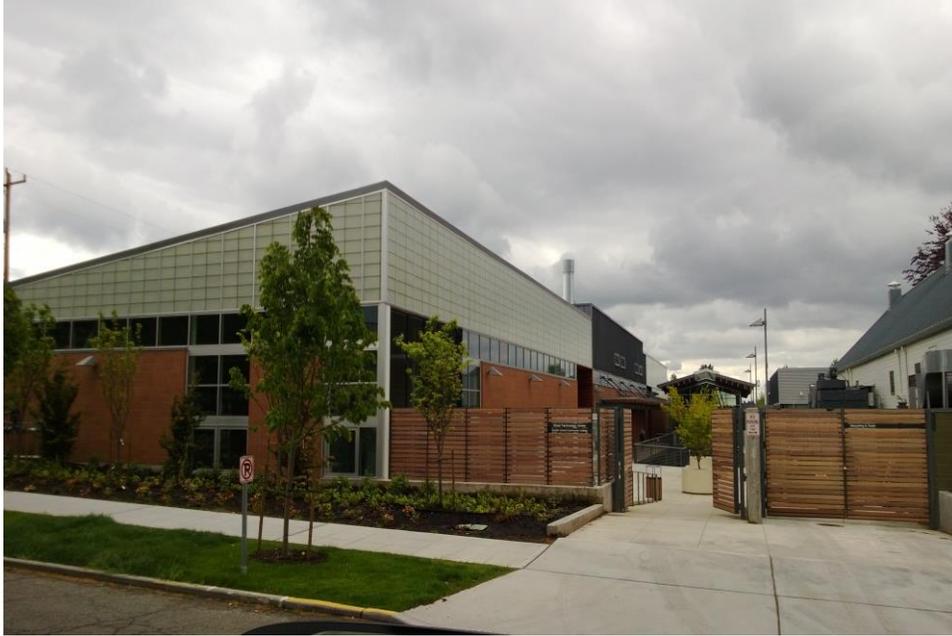
Wood Constr Center (062-WCC) STATE UFI: A10964 Wood Construction Campus (062B)
 AREA: 61,050 SF BUILT: 2012 REMODELED: No data PREDOMINANT USE: Vocational Arts
 CONSTRUCTION TYPE: No data CRV/SF: \$300 REPLACEMENT VALUE: \$18,315,000

Primary Systems	
COMPONENT: Structure	RATING: 1 x WEIGHT: 8.4 = SCORE: 8.4
No signs of settlement or cracking, no abrupt vertical changes Columns, bearing walls and roof structure appears sound/free of defects	
COMMENTS: No data	
COMPONENT: Exterior Closure	RATING: 1 x WEIGHT: 8.4 = SCORE: 8.4
Weatherproof, tight, well-maintained exterior walls, doors, windows/finishes	
COMMENTS: No data	
COMPONENT: Roofing	RATING: 1 x WEIGHT: 10.5 = SCORE: 10.5
Flashing and penetrations appear sound and membrane appears water- tight; drainage is positive and there are overflow scuppers	
COMMENTS: No data
