BROADWAY PERFORMANCE HALL DRAFT

EXTERIOR ENVELOPE CONDITIONS ASSESSMENT March 2016

Re: Broadway Performance Hall Masonry Consulting Project # 2065006

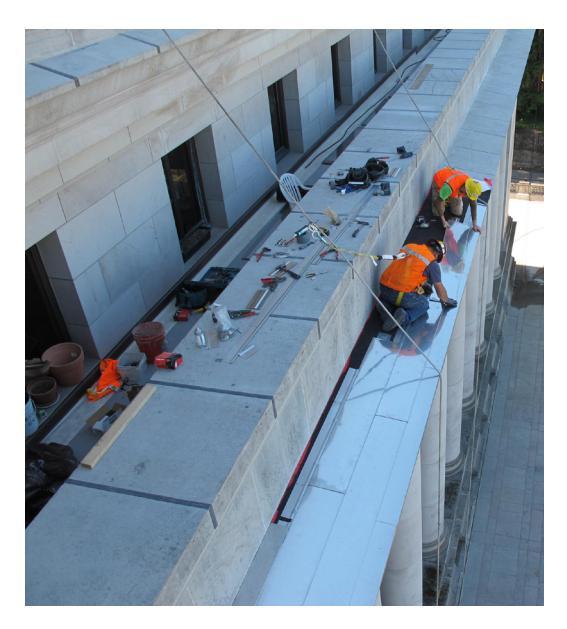
Fig. 10 Example of a metal cover installed over a wide stone ledge at Washington State Legislative Building in Olympia, WA

Skyfacing joints present a greater risk than vertical joints, and if left unrepaired, could present a water infiltration risk. Where skyfacing joints exist over covered areas, such as the (main) east entrance (Fig. 8 & 9), use of a non-reflective metal cover (Fig. 10) may be considered to promote positive drainage of water away from the building in addition to protecting the stone from water infiltration through both the stone surface and mortar or sealant joints.

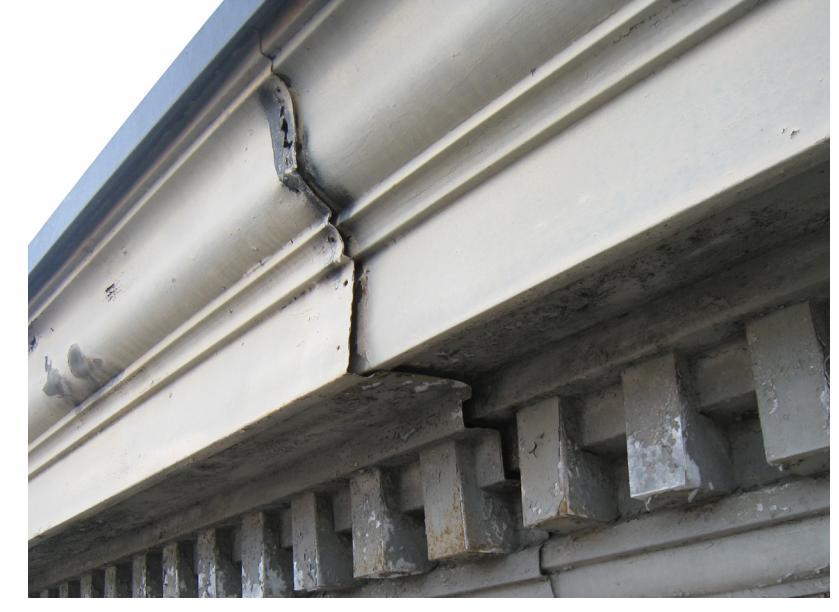
Fig. 18 Paint Failure at Ornamental Gutter Cover

The ornamental metal gutter cover, at roof level, exhibits signs of paint failure (Fig 18). In addition, it is detached in several locations. The cover should be removed, restored (including repainting), and reinstalled.

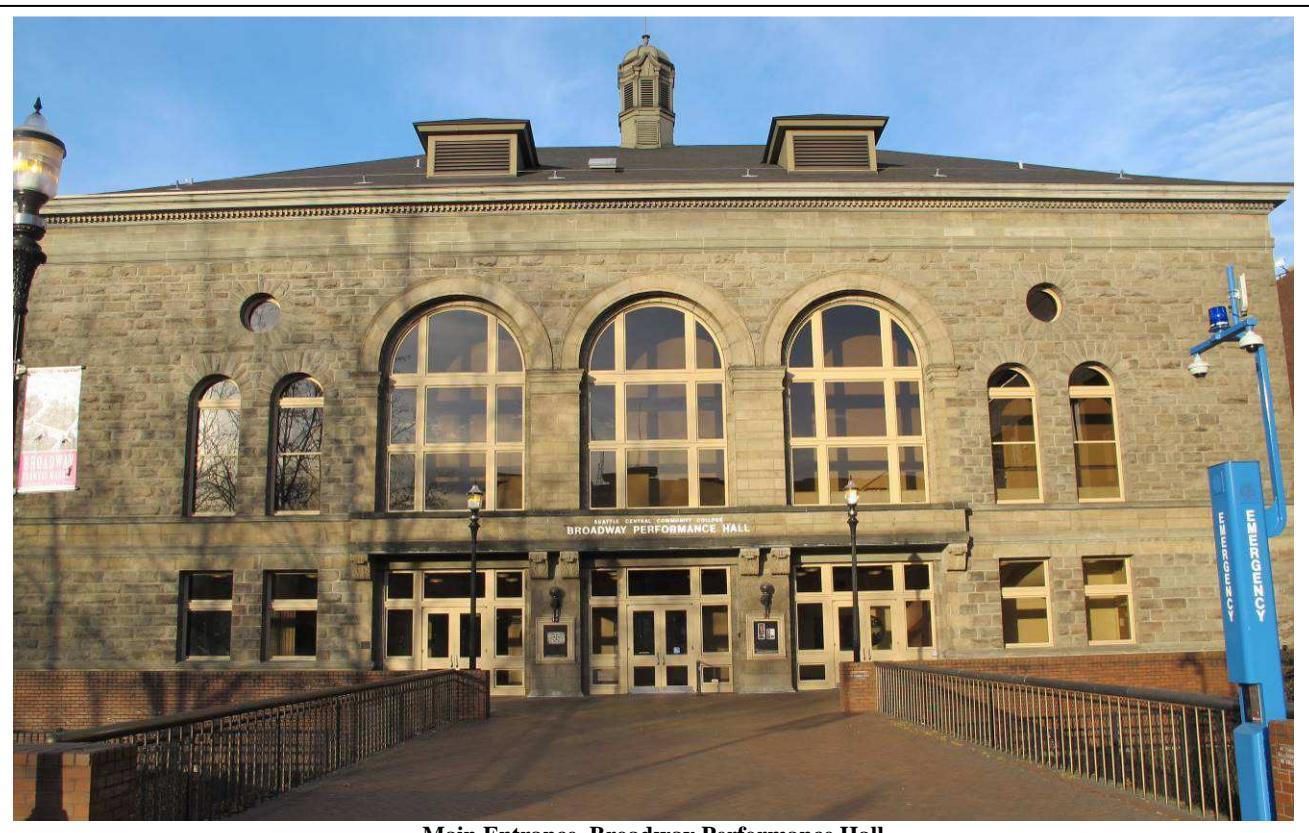
Main Entrance, Broadway Performance Hall
